FINAL
Hazardous Building
Materials
Assessment

30 King Street East,
Gananoque, ON

August 7, 2015

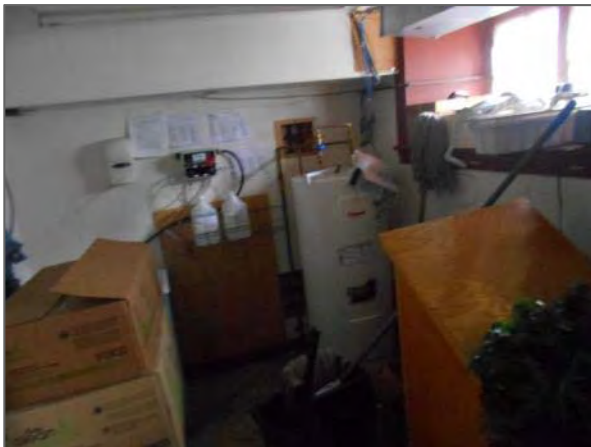
Mechanical equipment is insulated with non-asbestos fiberglass

Hot water tank insulated with non-asbestos fiberglass.

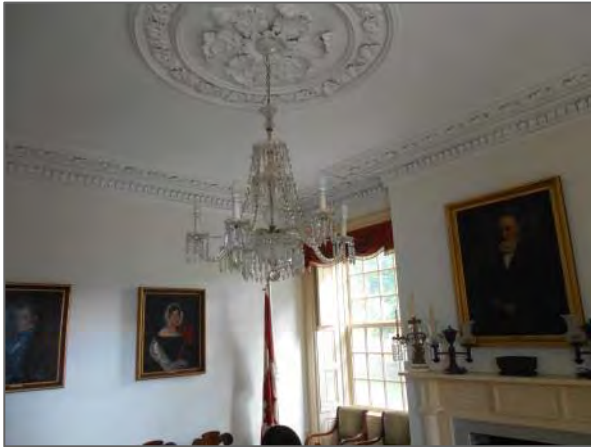
Plaster present on walls and ceilings in the building does not contain asbestos (samples 0001A-G).

Non-asbestos plaster present throughout the building.

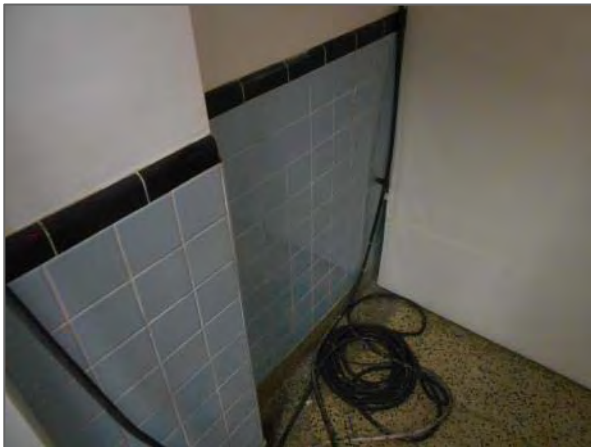
Drywall (gypsum board) and drywall joint compound present as a wall and ceiling finish in isolated locations throughout the building does not contain asbestos (samples 0003A-C).

Non-asbestos drywall joint compound present in isolated locations in the building.

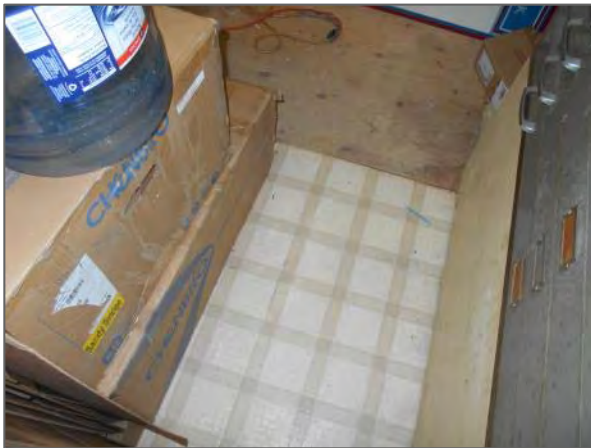
Pattern, Colour	Paper Backing (Yes/No)	Locations	Sample Number	Asbestos Type
Squares, white and brown	Yes	Basement furnace room	0002A-C	None Detected

Non-asbestos vinyl sheet flooring present in the basement furnace room.

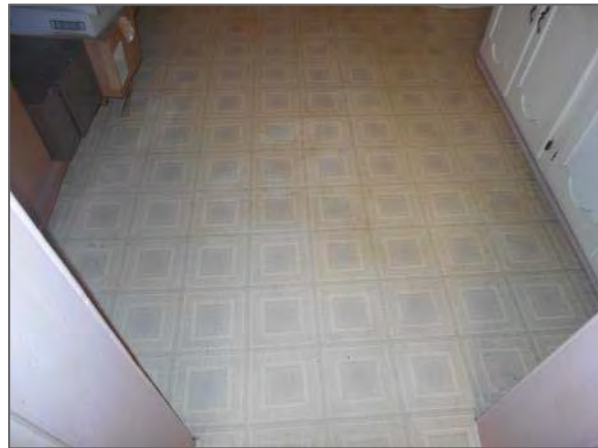
Pattern, Colour	Paper Backing (Yes/No)	Locations	Sample Number	Asbestos Type
Squares, white	Yes	Basement, women's washroom	0004A-C	None Detected

Non-asbestos vinyl sheet flooring present in the basement women's washroom.

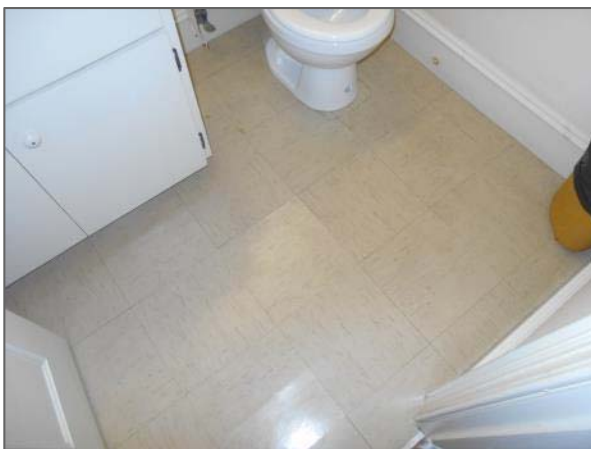
Non-friable 12" x 12" beige vinyl floor tiles with brown streaks, present in the third floor washroom contain chrysotile asbestos (Samples 0005A-C.) The vinyl floor tiles are in good condition.

Asbestos-containing vinyl floor tiles present in the third floor washroom.

If vinyl floor tiles must be removed as a result of planned renovation, etc., use Type 1 procedures as outlined within Ontario Regulation 278/05 if the work is done using wet methods and using hand-held non-powered tools.

Asbestos-containing materials must be disposed of at a landfill approved to accept asbestos waste.

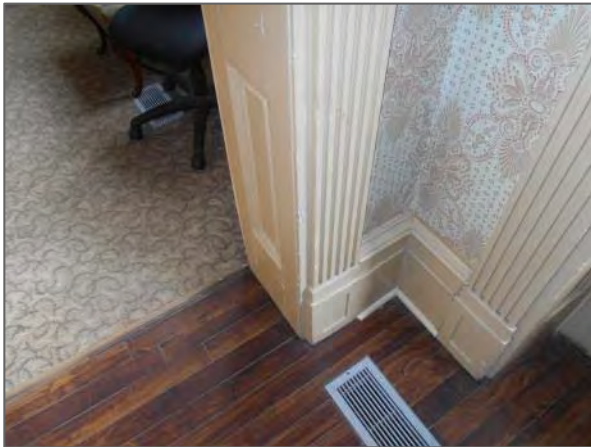
All paints containing elevated levels of lead were found to be in good condition and not flaking, peeling or delaminating.

Yellow painted wood trim containing elevated concentrations of lead (>1,000 ug/g).

Construction disturbance of lead in paint and coatings (or other materials) may result in over-exposure to lead dust or fumes. The need for work procedures, engineering controls and personal protective equipment will need to be assessed on a project-by-project basis and must comply with provincial standards or guidelines.

Lead-painted items may be a hazardous waste. Test lead-painted materials for leachable lead prior to disposal.

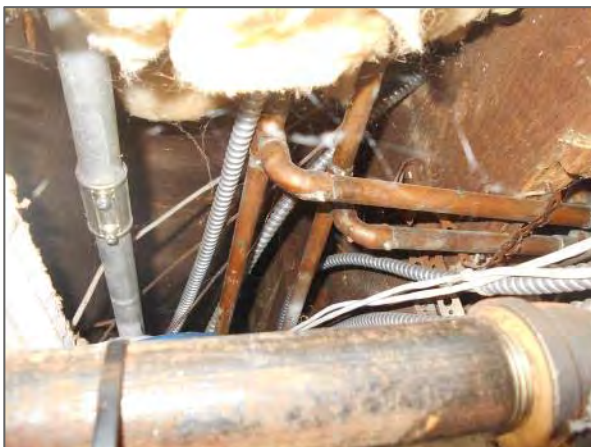
- electrical components, including wiring connectors, fibre optic cable sheathing, grounding conductors, and plumbing solder

Presumed lead-containing solder present on pipes in the building.

Lead-containing items should be recycled when taken out of service.

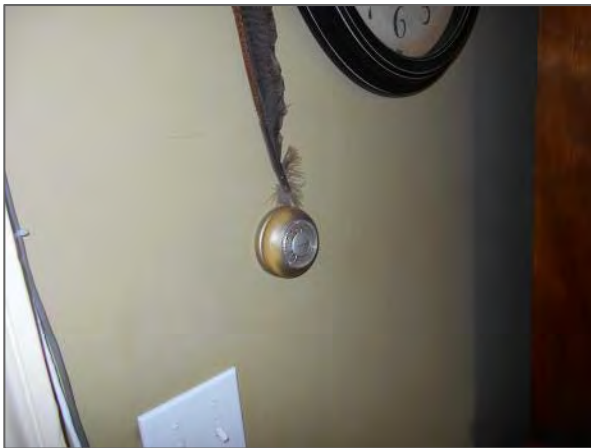
Mercury is present as a liquid in thermostats.

Mercury containing thermostat present in the building.

Do not break lamps or separate liquid mercury from components. Recycle and reclaim mercury from fluorescent light tubes and thermostats when taken out of service. Liquid mercury is classified as a hazardous waste and must be disposed of in accordance with local regulations.
