Hudson Bridge Preliminary Design Report

KEY PLAN
Hudson Bridge, Machar Street
Gananoque, Ontario

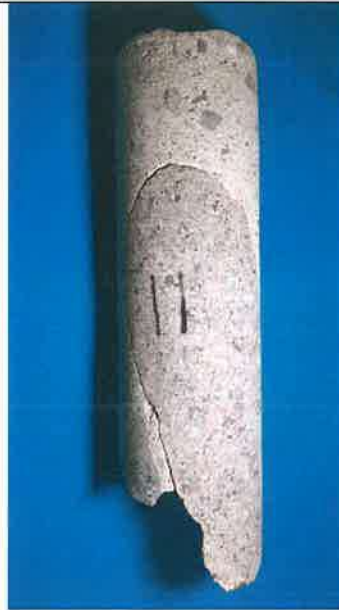
Bonding between the old concrete and patching grout and bonding between the rock and old concrete was noted to be very weak with total separation observed in many cases.

Photograph 1
Core #11 showing embedded natural rock with poor bond to concrete

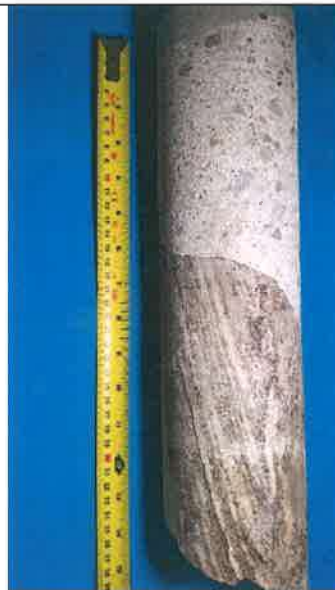
Cores consisting of some or all of the old concrete were observed to have no reinforcing steel embedded within the old concrete however, occasional large natural rocks were observed in the concrete mix (see attached photographs appended to this report).

Photograph 2
Core #16 showing embedded natural rock

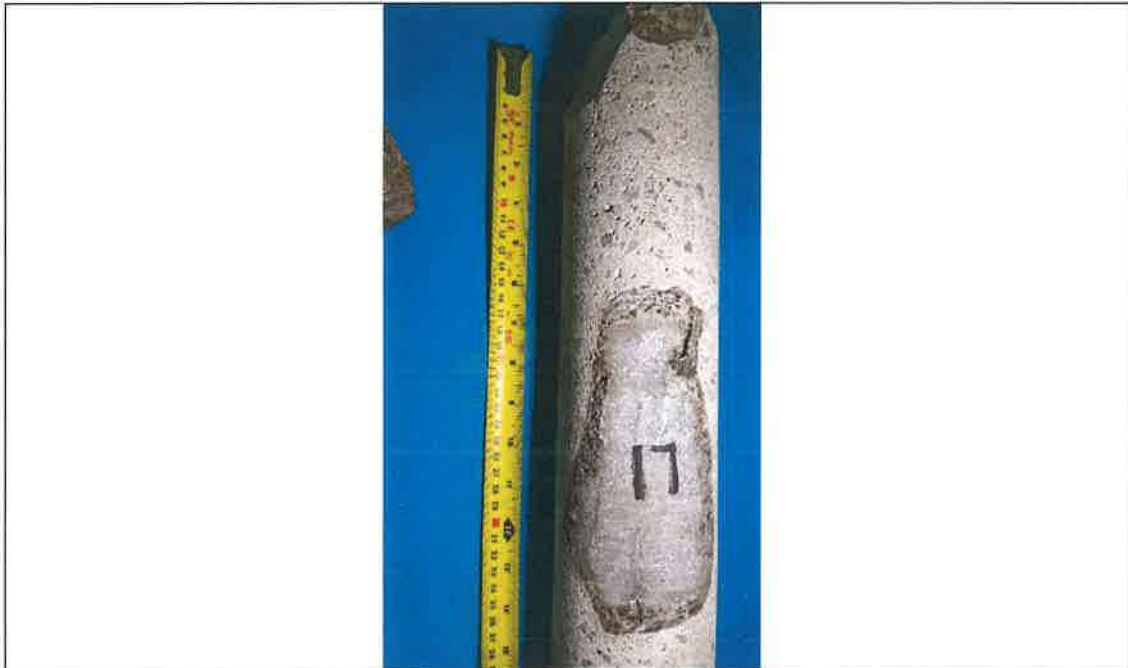
**Photograph 3.
Core #17 showing embedded natural rock**

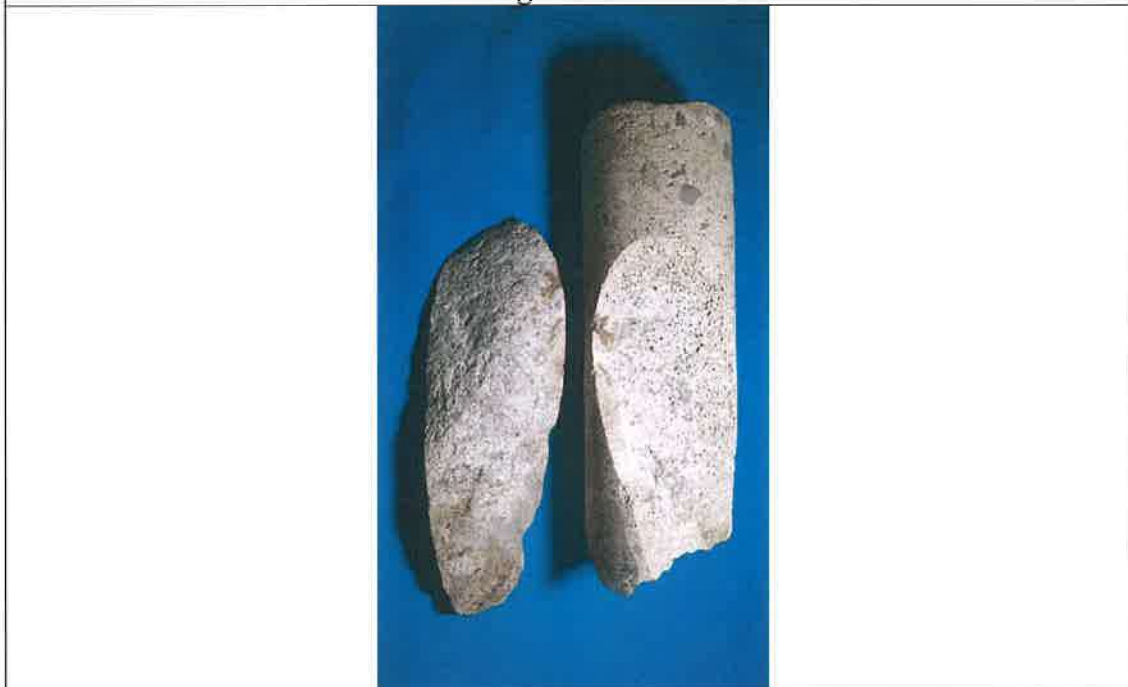
**Photograph 4.
Core #13 showing embedded rock completely debonded from concrete**
