2016 Bridge Inspections

Town of Gananoque

- June 2016 -

Keystone Bridge Management Corp.

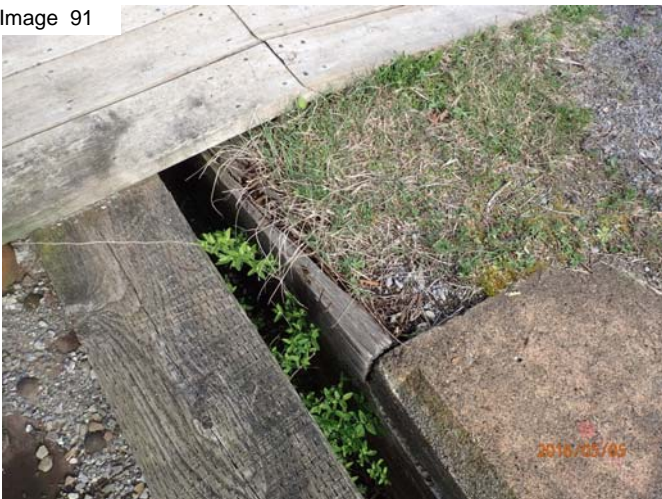
Image 91

RC Ballast Wall (2) Ballast Wall Length: 7.35 m Width: Height: 1.05 m	Defects	2.0%	Minor AAR Cracking	
	Damage	0.0%		
	Maintenance	Repair	Damage	Partial Inspection
	Capital Rec.	None		
			<i>Timber blocking at both deck ends is decayed and requires replacement as a maintenance item.</i>	
RC Wing Walls (4) Wing Walls Length: 4.2 m Width: Height: 3.15 m	Defects	40.0%	Moderate AAR Cracking, Minor Leaching/Seepage	
	Damage	1.0%	Moderate Disintegration, Minor Delamination	
	Maintenance	None		
	Capital Rec.	None		
			<i>Similar condition as abutments.</i>	
Steel Sliding Plate (4) Abutment Bearings Length: Width: Height:	Defects	0.0%		
	Damage	0.0%		
	Maintenance	Remove debris		
	Capital Rec.	None		
			<i>Debris around bearings should be removed. Disintegration of abutment wall encroaching on bearings.</i>	
Water Channel (1) Channel	Defects	0.0%		
	Damage	0.0%		
	Maintenance	None		
	Capital Rec.	None		
			<i>No concerns.</i>

Rotted timber north ballast

Thorough cleaning of bottom chord of truss and bearing seat required. Plan for replacing timber retaining walls in all four corners. Replace timber blocking at both ballast walls.

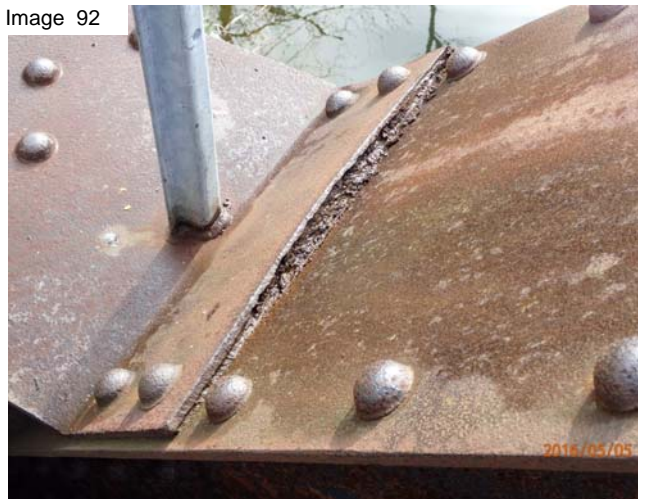
Image 92

Typical rust on northeast diagonal

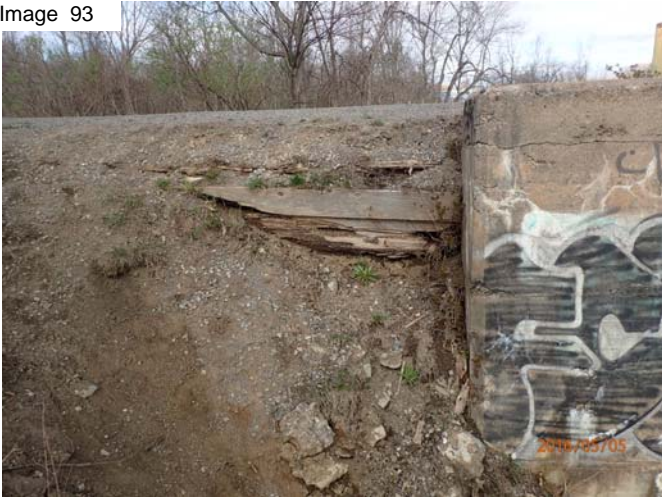
Image 93

Embankment (2) Embankment	Defects	10.0%	Moderate Erosion	
	Damage	0.0%		
	Maintenance	Slope revetment		
	Capital Rec.	None		Perf Def: Over-steepened
			<i>Southeast timber retaining wall has failed. Excessive erosion should be repaired. Timber retaining wall in other corners beginning to deteriorate.</i>	
Delineator (4) Signs Length: Width: Height:	Defects	0.0%		
	Damage	0.0%		
	Maintenance	Replace Sign		
	Capital Rec.	None		
			<i>Missing one delineator in SW corner.</i>

Erosion southeast corner

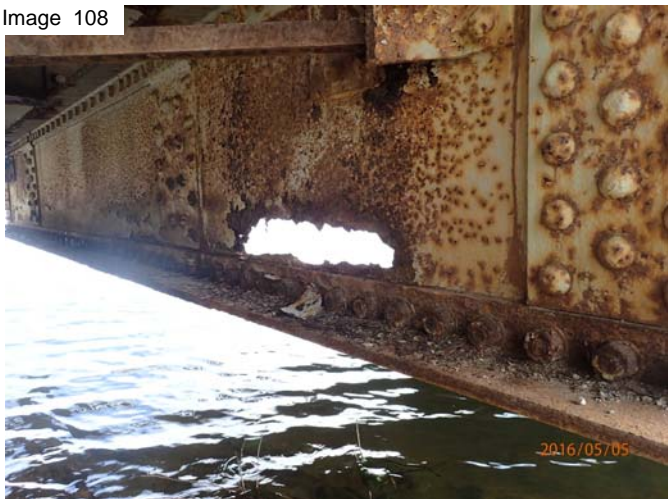
Image 108

Steel Floor Beam (6)	Defects 95.0% Moderate Corrosion	
Floor Beams	Damage 5.0% Minor Perforation, Moderate Section Loss	
Length: 5 m	Maintenance None	Partial Inspection
Width:	Capital Rec. None	
Height: 0.69 m	<i>Perforations noted on two west most floor beams. A boat inspection is recommended to review condition of all floor beams from close up.</i>	
Steel Floor Beam (49)	Defects 5.0% Minor Corrosion	
Steel Deck Ties	Damage 0.0%	
Length: 6.5 m	Maintenance None	Partial Inspection
Width:	Capital Rec. None	
Height: 0.27 m	<i>These members are part of the deck system and a retrofit to the bridge. No concerns noted.</i>

West floor beam perforation

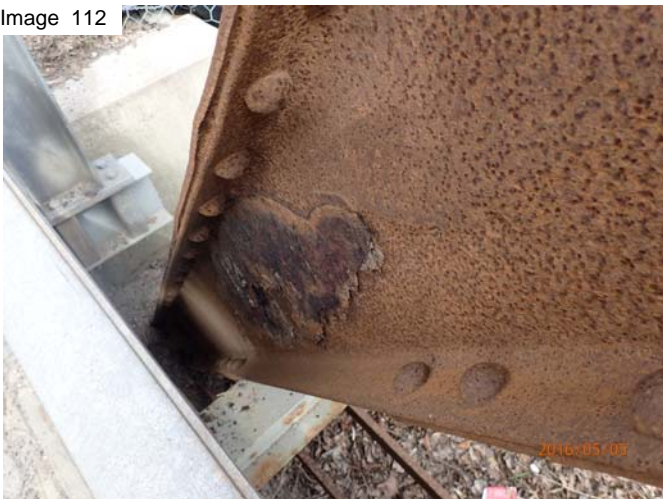
Image 112

Pitted truss northwest end diagonal

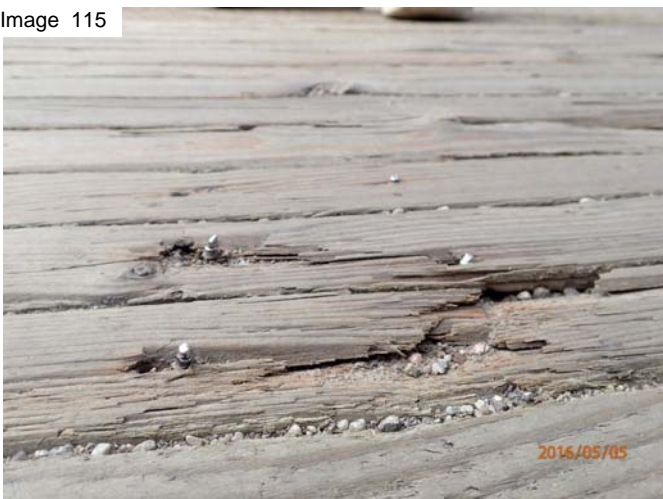
Image 115

Timber has major rutting, allowing screws and steel spacers to protrude through deck. Recommend placing asphalt padding until deck can be replaced.

Screws protruding through deck

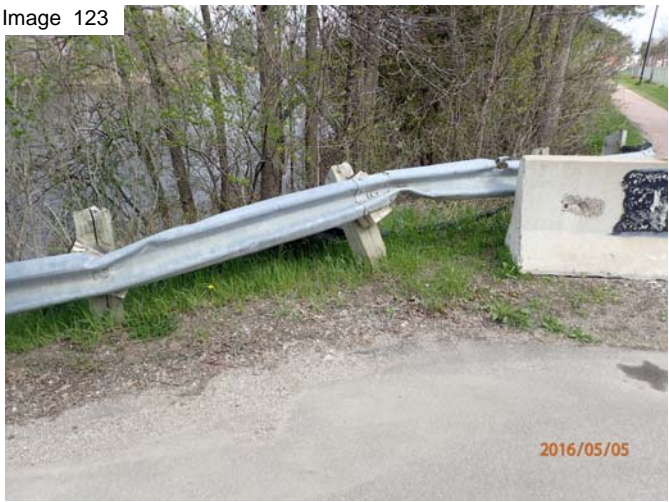
Image 123

Good condition, secure. Approach guiderail in NE corner has impact damage.

Northeast guardrail

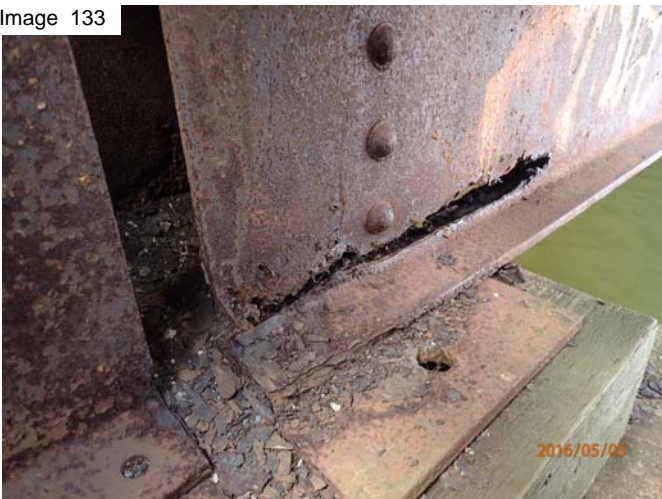
Image 133

This bridge is located immediately upstream of the dam. It consists of three spans of a railway bridge that was converted to pedestrian use. The girder ends at the piers and abutments are exhibiting severe corrosion with perforation. The west end of this bridge is experiencing web crippling of the girders and is slowly failing.

Perforated girder on west pier

The bridge is still safe for pedestrian use but could “settle” due to girder web failure, and result in alarm to the public. It would be prudent for the Town to not risk losing the public’s confidence in this trail bridge by replacing it before the girder webs fail much further.

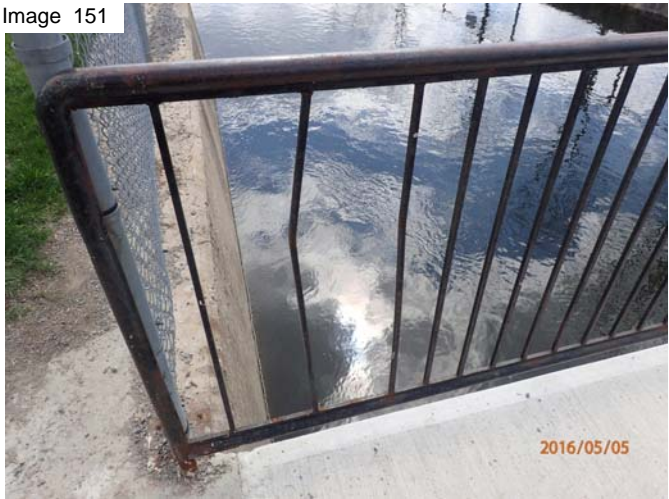
Bent railing segment

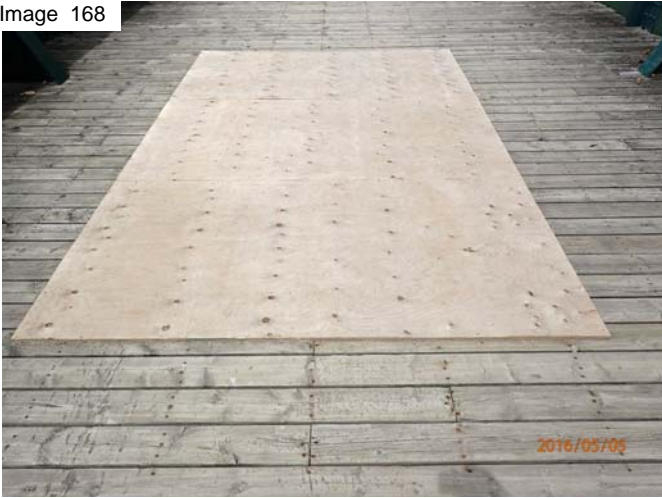
Image 168

The wood deck of this bridge experienced a punching type failure from a maintenance vehicle the past winter. Further investigation of the failure revealed decay of the deck planking and it is suspected that the supporting wood stringers are also experiencing scattered decay.

Patched hole in deck

It is recommended to plan on replacing the timber deck by 2018.

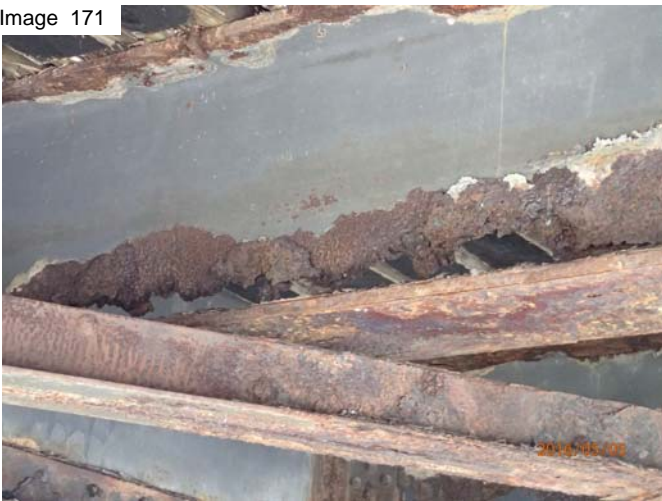
Image 171

The remainder of the bridge has been largely neglected and is in a state of very poor repair. There are gaping holes from corrosion in parts of the bridge's floor system. When this level of severe corrosion is visible from standing beneath the bridge, one has to wonder how severe the corrosion is in other less visible areas of the bridge.

Perforated West floor beam at north end

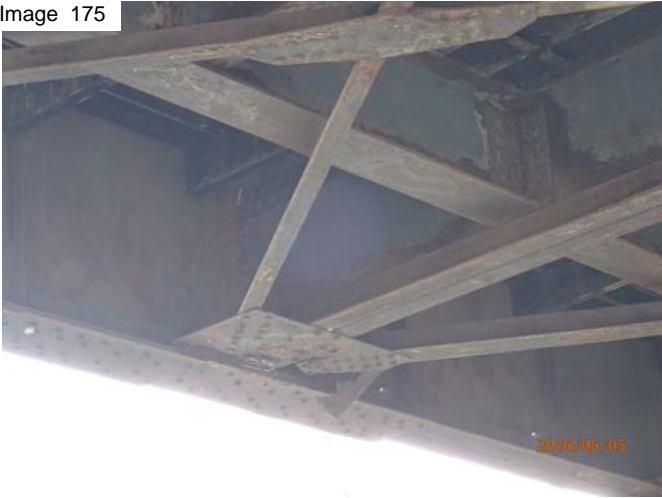
Image 175

Perforated gusset plate on west side worth of pier

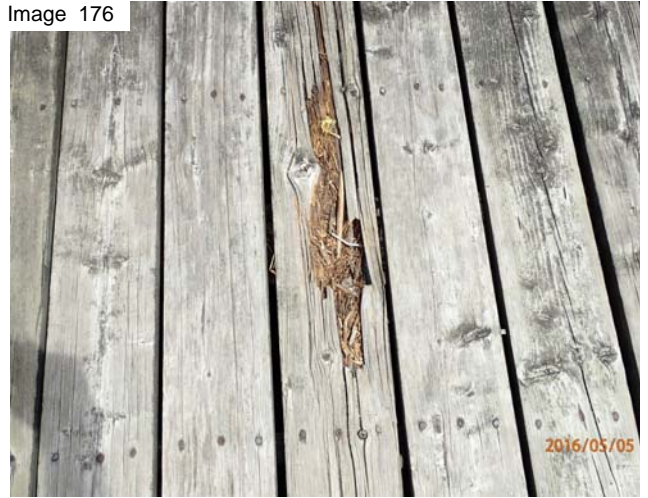
Image 176

Typical decayed deck board

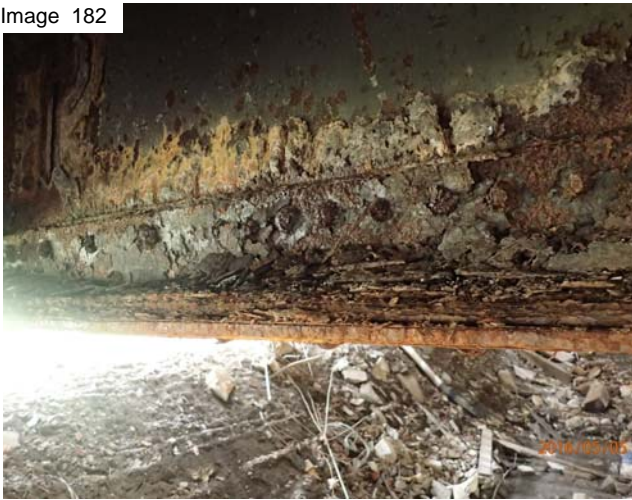
Image 182

Typical debris and corrosion on floor beam
