Arborist Report

Gananoque Town Hall
30 King St E, Gananoque, Ontario

October 3, 2016

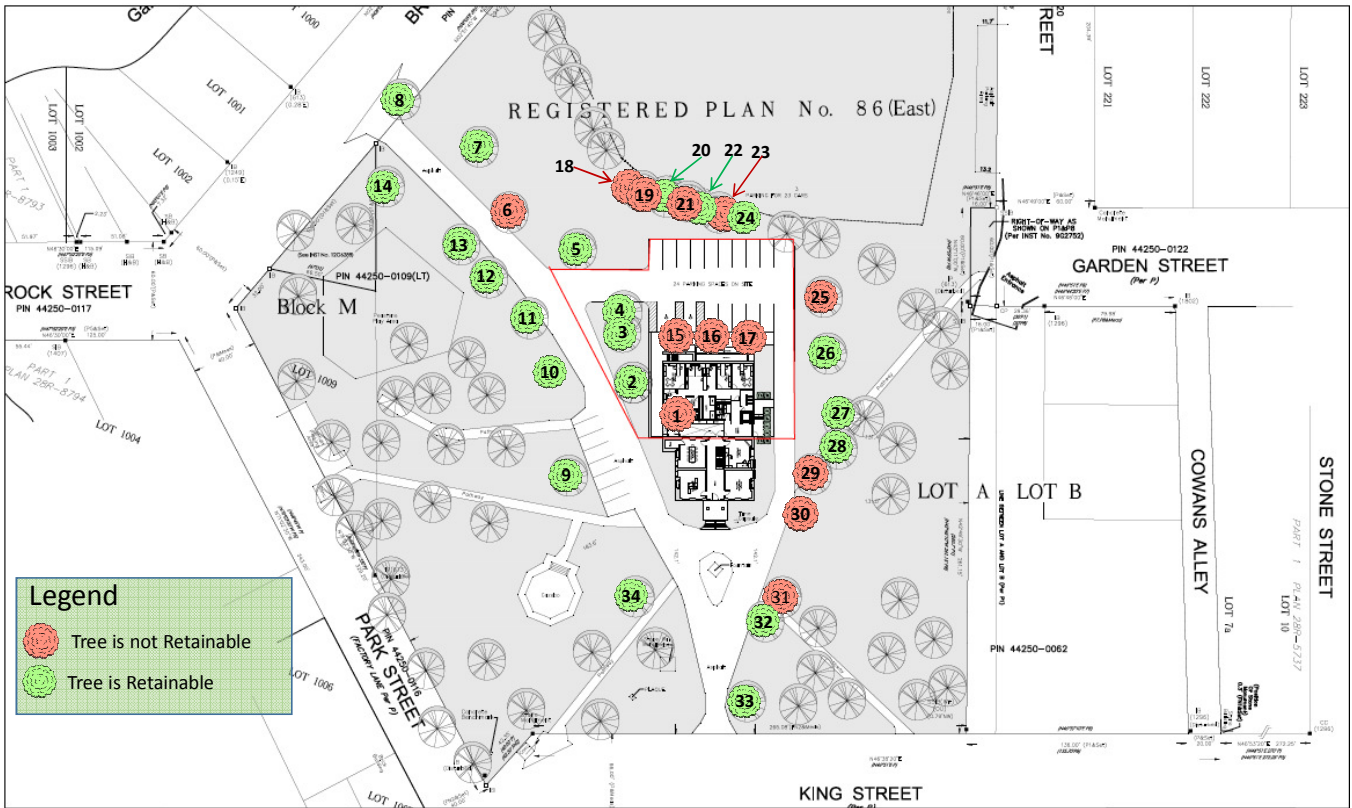
Figure 2: Map of trees that may be injured or destroyed at Town Hall

ID	Type	Species	DBH (cm)	Condition	Retainable?	Observations
1	Deciduous	Norway Maple	48	Fair	No	Tree has poor form Tree will require removal as a result of being in path of building expansion
2	Deciduous	Norway Maple	26	Fair	Yes	Tree has good form Tree will require root pruning
3	Deciduous	White Ash	75	Good	Yes	Tree will require EAB treatment to preserve specimen Tree will require root pruning
4	Deciduous	Sugar Maple	59	Fair	Yes	Tree will require root pruning
5	Deciduous	Sugar Maple	78	Good	Yes	Tree will require root pruning
6	Deciduous	Silver Maple	124	Fair	No	Tree will not be able to cope with construction activities – tree is too close to road rehabilitation efforts
7	Deciduous	Norway Maple	31	Good	Yes	Tree will require root pruning
8	Deciduous	Bur Oak	14	Good	Yes	Tree will require root pruning
9	Deciduous	Black Cherry	11	Good	Yes	Tree will require root pruning
10	Deciduous	Silver Maple	19	Good	Yes	Tree will require root pruning

11	Deciduous	Norway Maple	36	Good	Yes	Tree will require root pruning
12	Deciduous	Honey Locust	8	Good	Yes	Tree has good form Tree will cope with construction activities

13	Deciduous	Norway Maple	57	Good	Yes	Tree has girdling roots Tree will require root pruning
14	Deciduous	Norway Maple	35	Fair	Yes	Tree has girdling roots Tree will require root pruning
15	Deciduous	Siberian Elm	75	Good	No	Tree will require removal as a result of being in direct conflict of parking lot expansion
16	Deciduous	Norway Maple	26	Fair	No	Tree will require removal as a result of being in direct conflict of parking lot expansion
17	Deciduous	Norway Maple	19	Fair	No	Tree will require removal as a result of being in direct conflict of parking lot expansion
18	Deciduous	White Ash	22	Fair	No	Tree has been harmed by Emerald Ash Borer and will require removal and replacement
19	Coniferous	Norway Spruce	15	Good	No	Tree will require removal as a result of being too close to edge of parking lot extension
20	Deciduous	Sugar Maple	28	Good	Yes	Tree will require root pruning
21	Coniferous	White Spruce	20	Good	No	Tree will require removal as a result of being too close to edge of parking lot extension

22	Deciduous	Silver Maple	33	Good	Yes	Tree will require root pruning
23	Coniferous	White Spruce	24	Fair	No	Tree will require removal as a result of being too close to edge of parking lot extension
24	Deciduous	White Ash	27	Fair	Yes	Tree will require EAB treatment to preserve this specimen Tree will require root pruning
25	Deciduous	Sugar Maple	92	Fair	Yes	Tree will require root pruning

26	Deciduous	Sugar Maple	26	Fair	Yes	Tree will require root pruning
27	Deciduous	Sugar Maple	58	Fair	Yes	Tree will require root pruning
28	Deciduous	Sugar Maple	46	Fair	Yes	Tree will require root pruning
29	Deciduous	Sugar Maple	73	Poor	No	Tree removal is suggested. Tree is experiencing significant dieback and construction activities will adversely affect the long term health of this tree
30	Deciduous	Red Maple	8	Poor	No	Tree removal is suggested. This tree is experiencing dieback and has experienced frost cracking
31	Deciduous	Norway Maple	41	Poor	No	Tree removal suggested. Tree has poor form and large Eutypella canker that has compromised tree structure and tree health
32	Deciduous	Norway Maple	26	Fair	Yes	Tree will require root pruning
33	Deciduous	Silver Maple	92	Good	Yes	Tree will require root pruning
34	Deciduous	Sugar Maple	18	Good	Yes	Tree will require root pruning

A minimum of ten trees will require removal as a direct result of being within the planned area of expansion of town hall and its associated parking areas. An additional three trees will also require removal due to poor health conditions. All recommended tree removals must take place prior to the commencement of construction activities to mitigate the risk of damaging trees that could lead to structural failure. Figure 2 consists of a map showing all trees that will be affected by construction activities (see appendix B). Some of these trees will require removal.

Twenty-two trees will be affected by construction on this site but removal is unnecessary. These trees vary greatly in size and age and consist of eleven different species. These trees will be affected primarily by the disturbance of soils including trenching, paving, and soil compaction. If any damage should occur to the trunk and/or limbs of a tree, correctional treatment such as wound tracing and/or pruning shall take place to reduce the introduction of decay into these wounds. These corrective measures should be implemented as soon as possible after construction activities take place. Figure 1 represents an inventory of all 35 trees expected to be affected by construction activities (see appendix A). It also provides a general description of tree condition and recommendations to help those trees during and after construction.
