Phase I Environmental Site Assessment

185 Mill Street, Gananoque, Ontario

KIN-26260-A0

April 25, 2013

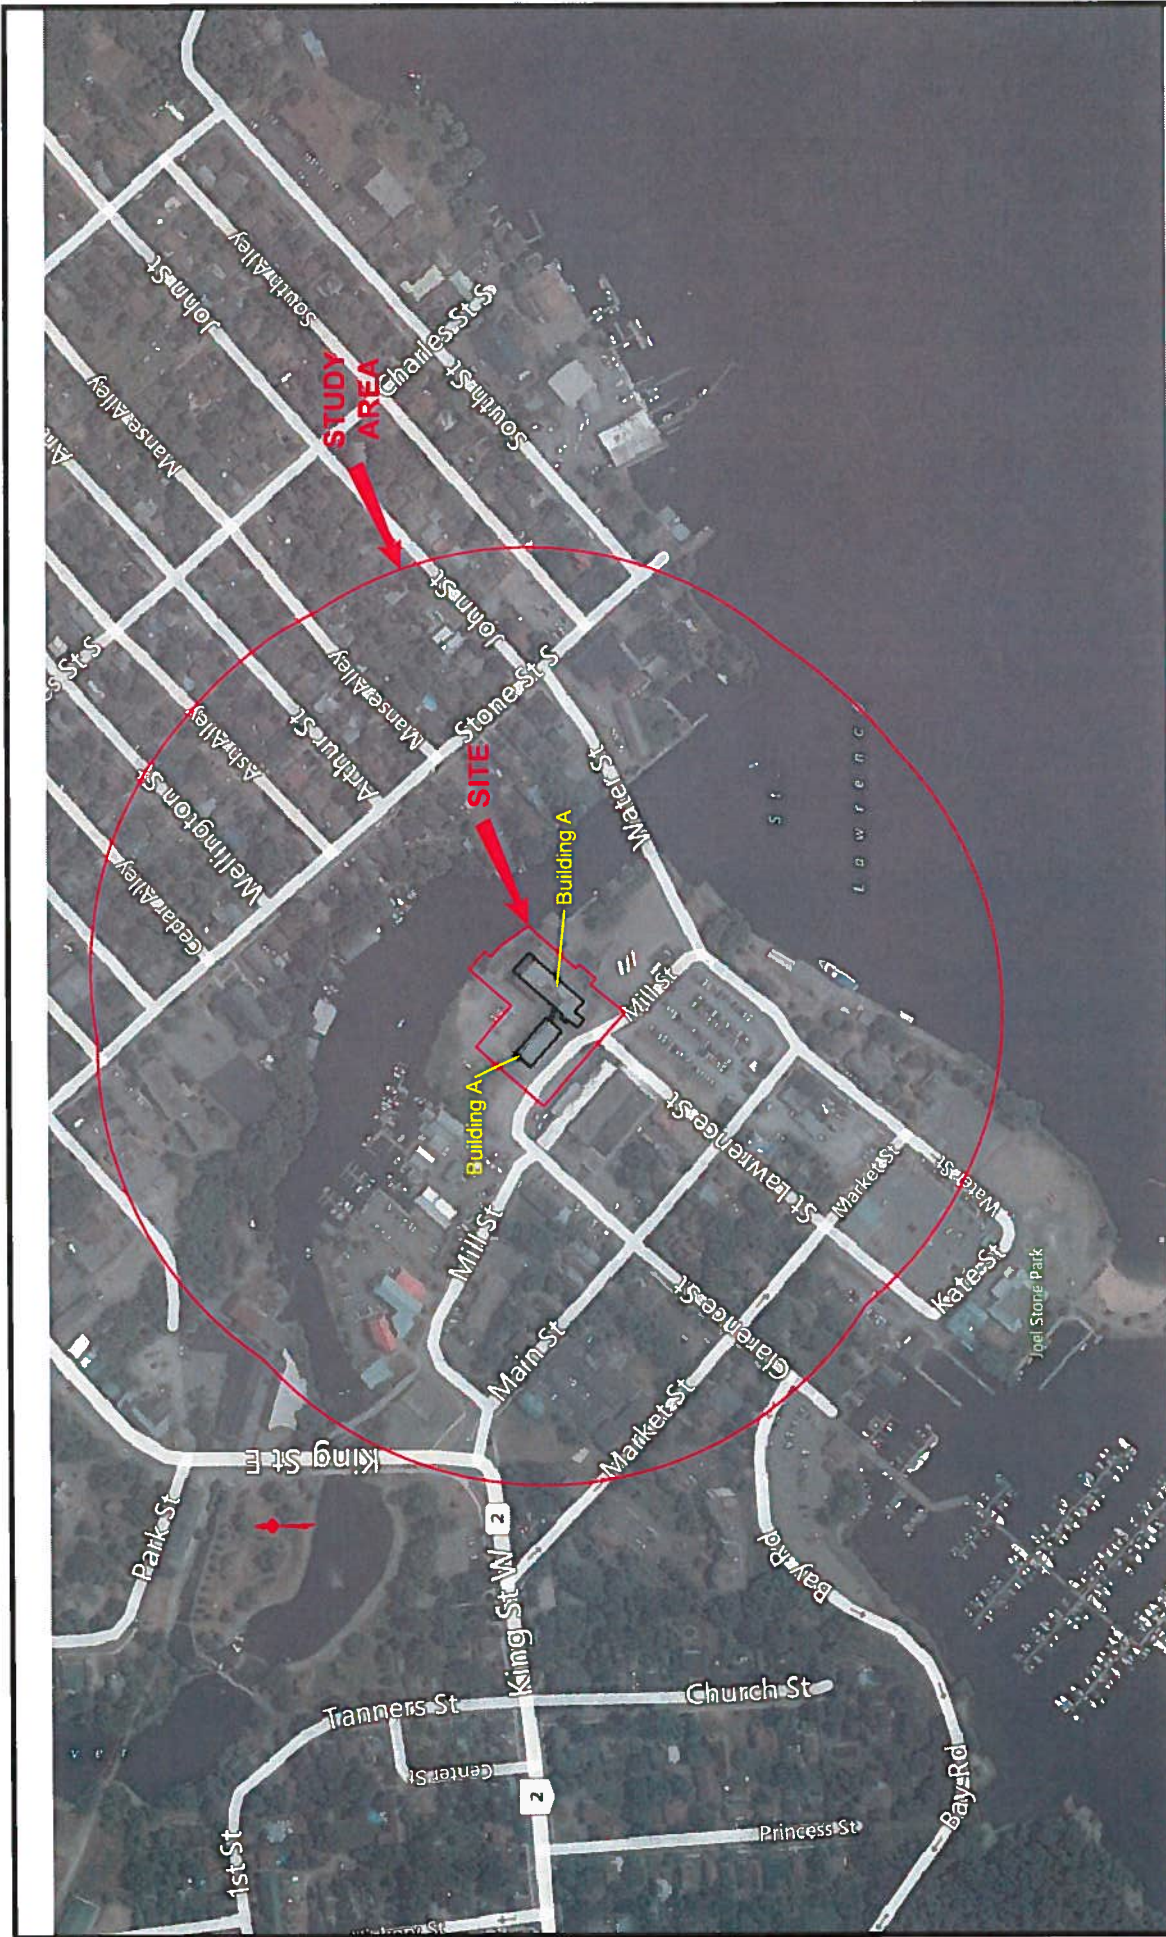
DATE: APRIL 2013	CLIENT: BRENNAN CUSTOM HOMES INC.	DRAWING NO: FIG. 1b
SCALE: 1:750	TITLE: SITE PLAN - SCHEMATIC 185 MILL STREET GANANOQUE, ONTARIO	PROJECT NO: KIN-26260-A0

The Site, located at 185 Mill Street is situated on the north-east side of Mill Street and south-west shore of the Gananoque River (Figure 1). The Site is approximately rectangular in shape and measured approximately 0.57 hectares. Two buildings are situated on the property (Figure 1b). The northern building (Building A) was constructed circa 1869 and the southern building (Building B) was constructed circa 1897. The buildings are presently vacant and unoccupied with the doors and windows boarded up. There are remnants of a third building located at the southeast end of the property. The majority of the exterior grounds are graded with gravel. A boat launch and dock were situated along the shore of the Gananoque River at the north-east end of the Site. The Site slopes north-easterly from Mill Street toward the Gananoque River.

- Building A (Figure 1b) at the Site was approximately twice the size as its present state with extensions at the north-east and south-west ends of the building. The main area of the building (which corresponds with the present location of Building A) was labelled as spool storage and empty container storage. The north-east extension of the building was labelled as auto body repairs and the south-west extension was labelled as vacant.

- Building B (Figure 1b) at the Site was labelled as steam moulding and machine shop, assembling and warehouse and woodworking. Spray painting was indicated at the northern end and nickel plating was indicated at the eastern end of Building B. A boat house was located at the north-east end of the building. Additionally, two smaller buildings were located southeast of the south building labelled as a machine shop and garage and as a maintenance shop and coal boiler room. Furthermore, a gate house and auto garage were located south-west of the south building and a shipping dock and lumber storage warehouse were located south of Building B. A coal yard was shown south of the Site buildings. This location is now part of the adjacent property to the South.

Quite-Eco conducted a groundwater investigation entailing the installation of three monitoring wells (MW03, MW04 and MW05) into the overburden. The approximate locations of the monitoring wells are shown in Figure 1b. Bedrock refusal was reported at 2.74, 1.82 and 2.13 metres at MW03, MW04 and MW-05, respectively. Groundwater samples were collected from each of the newly installed monitoring wells for analysis of VOCs and metals. Soil samples were not submitted. VOCs were not detected in the water samples at all three newly installed monitoring wells. Various metals were detected at concentrations exceeding the applicable MOE (2004) SCS as follows:
