STAGE 1 AND 2
ARCHAEOLOGICAL ASSESSMENT
BAY ROAD AND ROTARY BEACH UPGRADES
GEOGRAPHIC TOWNSHIP OF LEEDS
TOWN OF GANANOQUE, ONTARIO

PRAS Project No.: PR16-08

Date: July 26th, 2016
Original Report

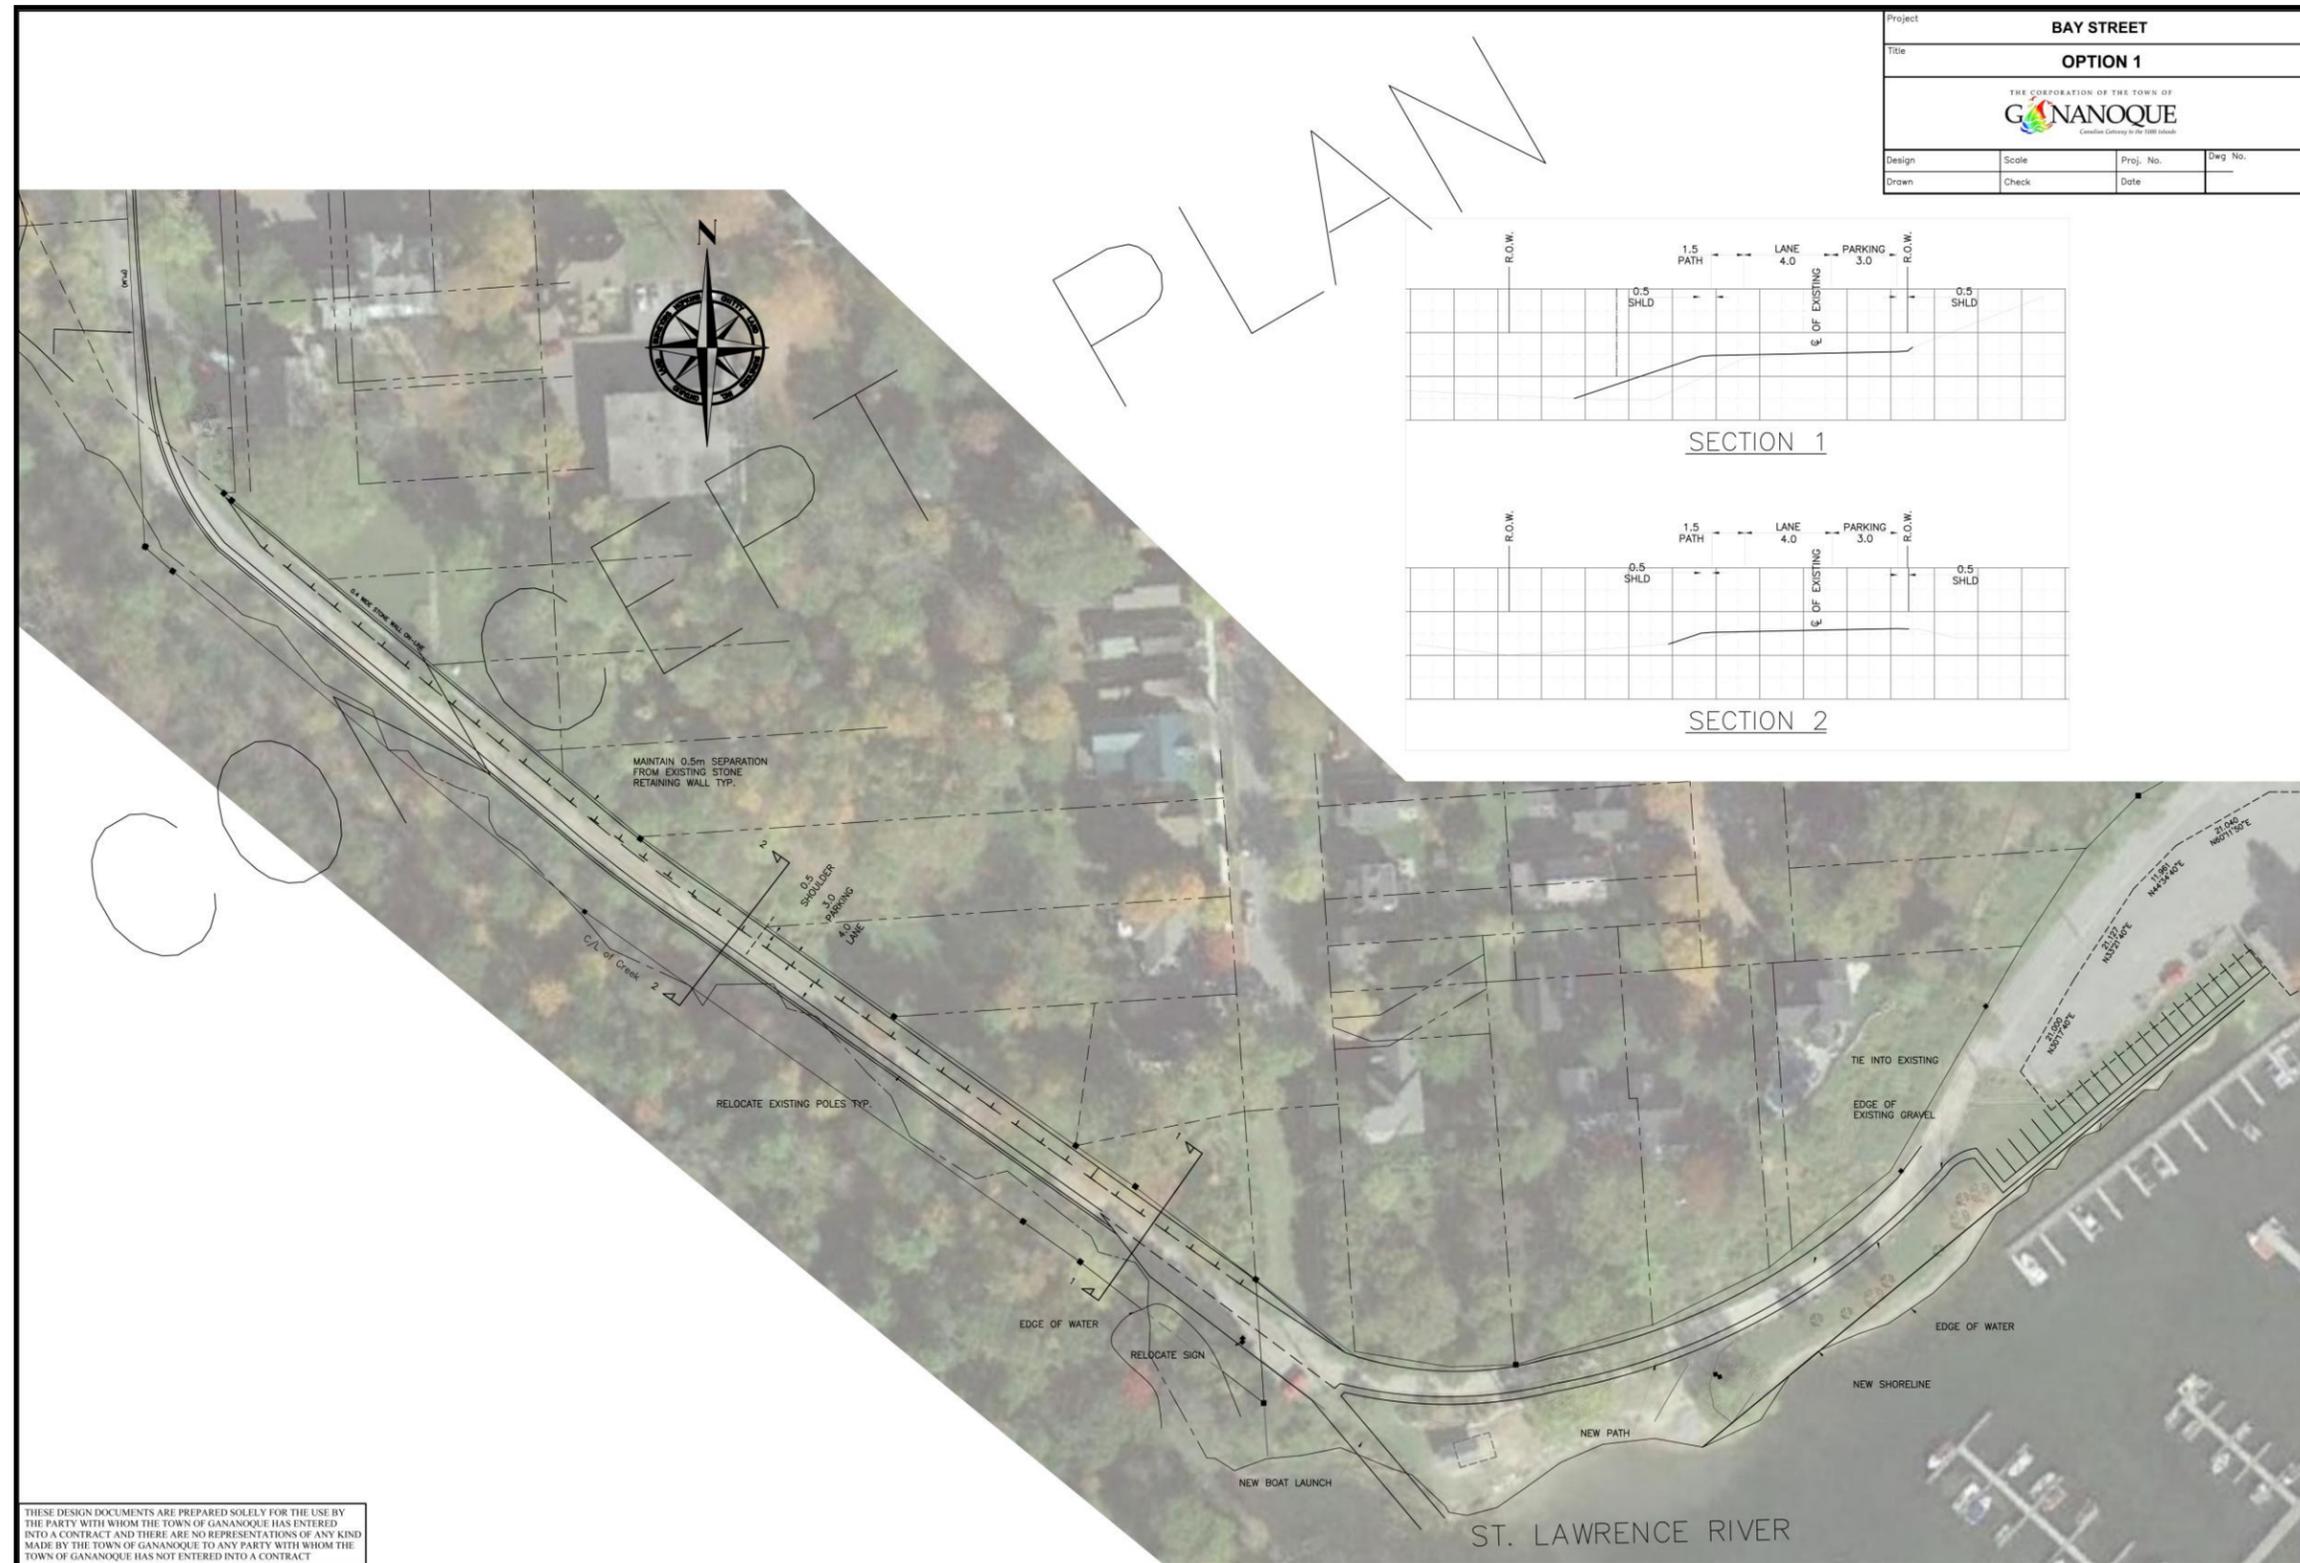
Map 3. Development plan.

The Town of Gananoque required the Stage 1 and 2 archaeological assessment as part of a Municipal Class Environmental Assessment being prepared in advance of proposed upgrades to the roadway and beach. The upgrades would see the widening and resurfacing of the existing roadway and the installation of storm sewers, lighting and a boat launch. A concept plan outlining the proposed developments within the study area was provided to Past Recovery by G.D. Jewell Engineering Inc., and has been reproduced as Map 3.

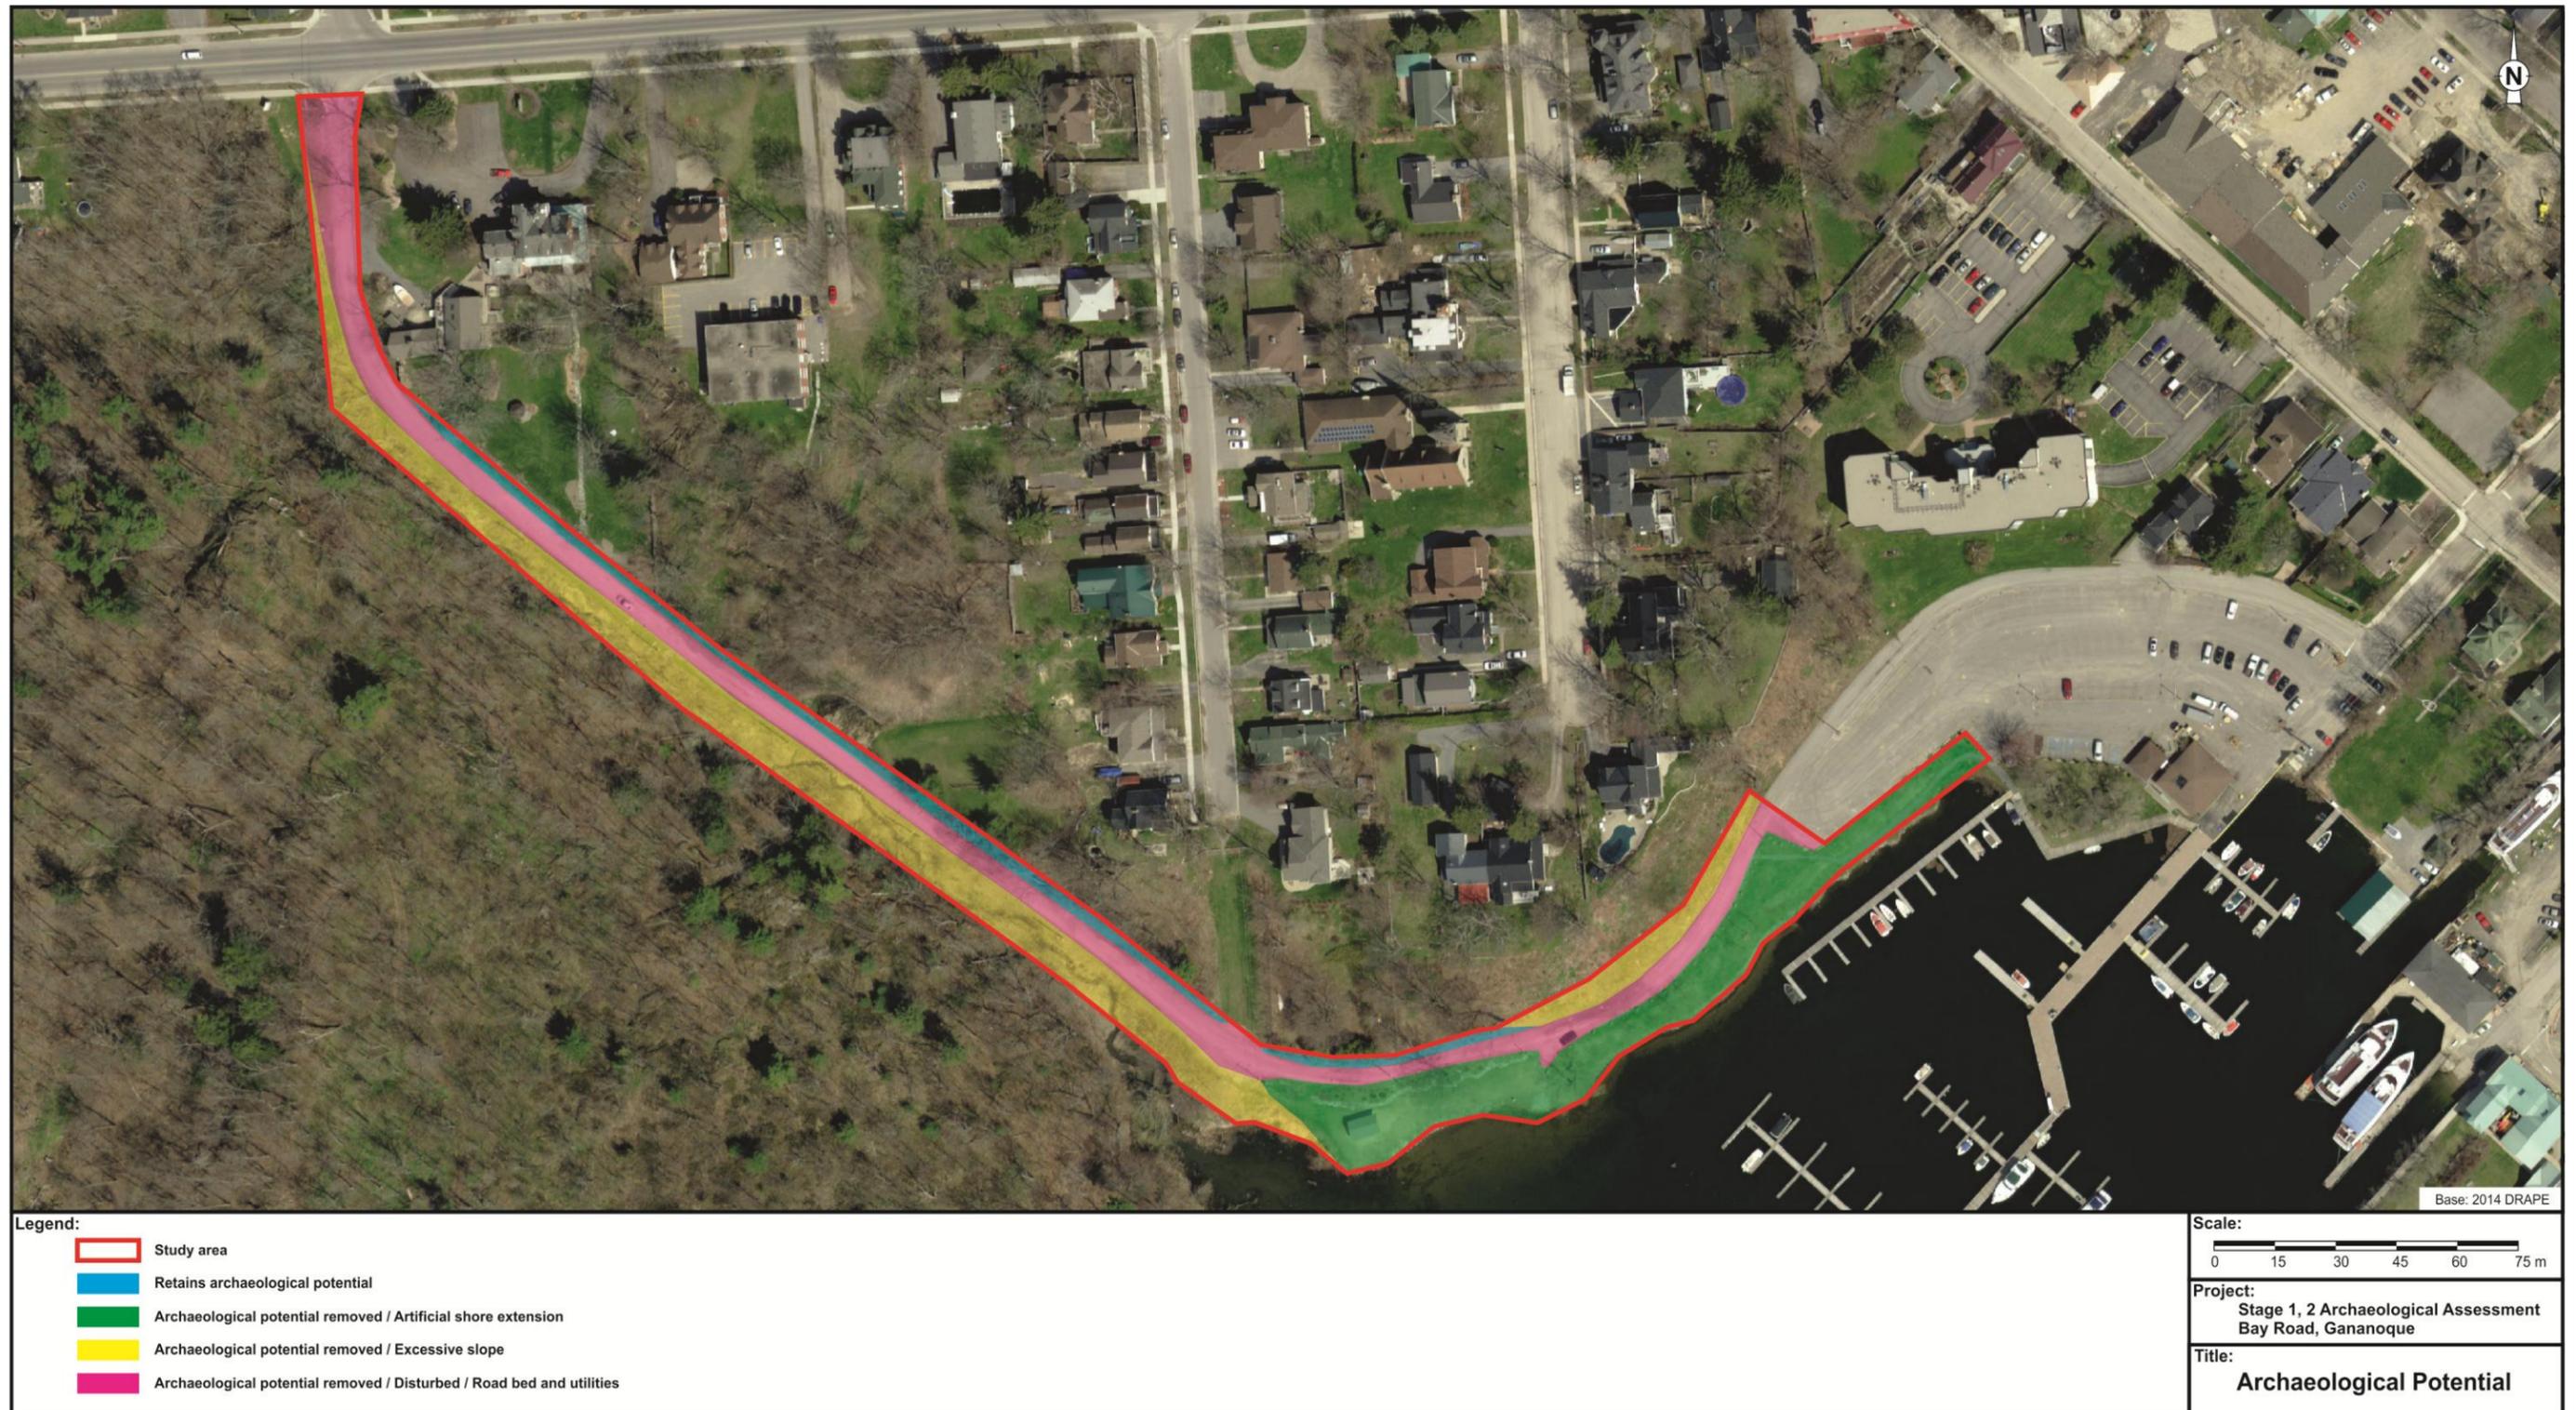
Map 11. Recent orthophotographic image of the study area with colour overlay indicating the archaeological potential of the study area.

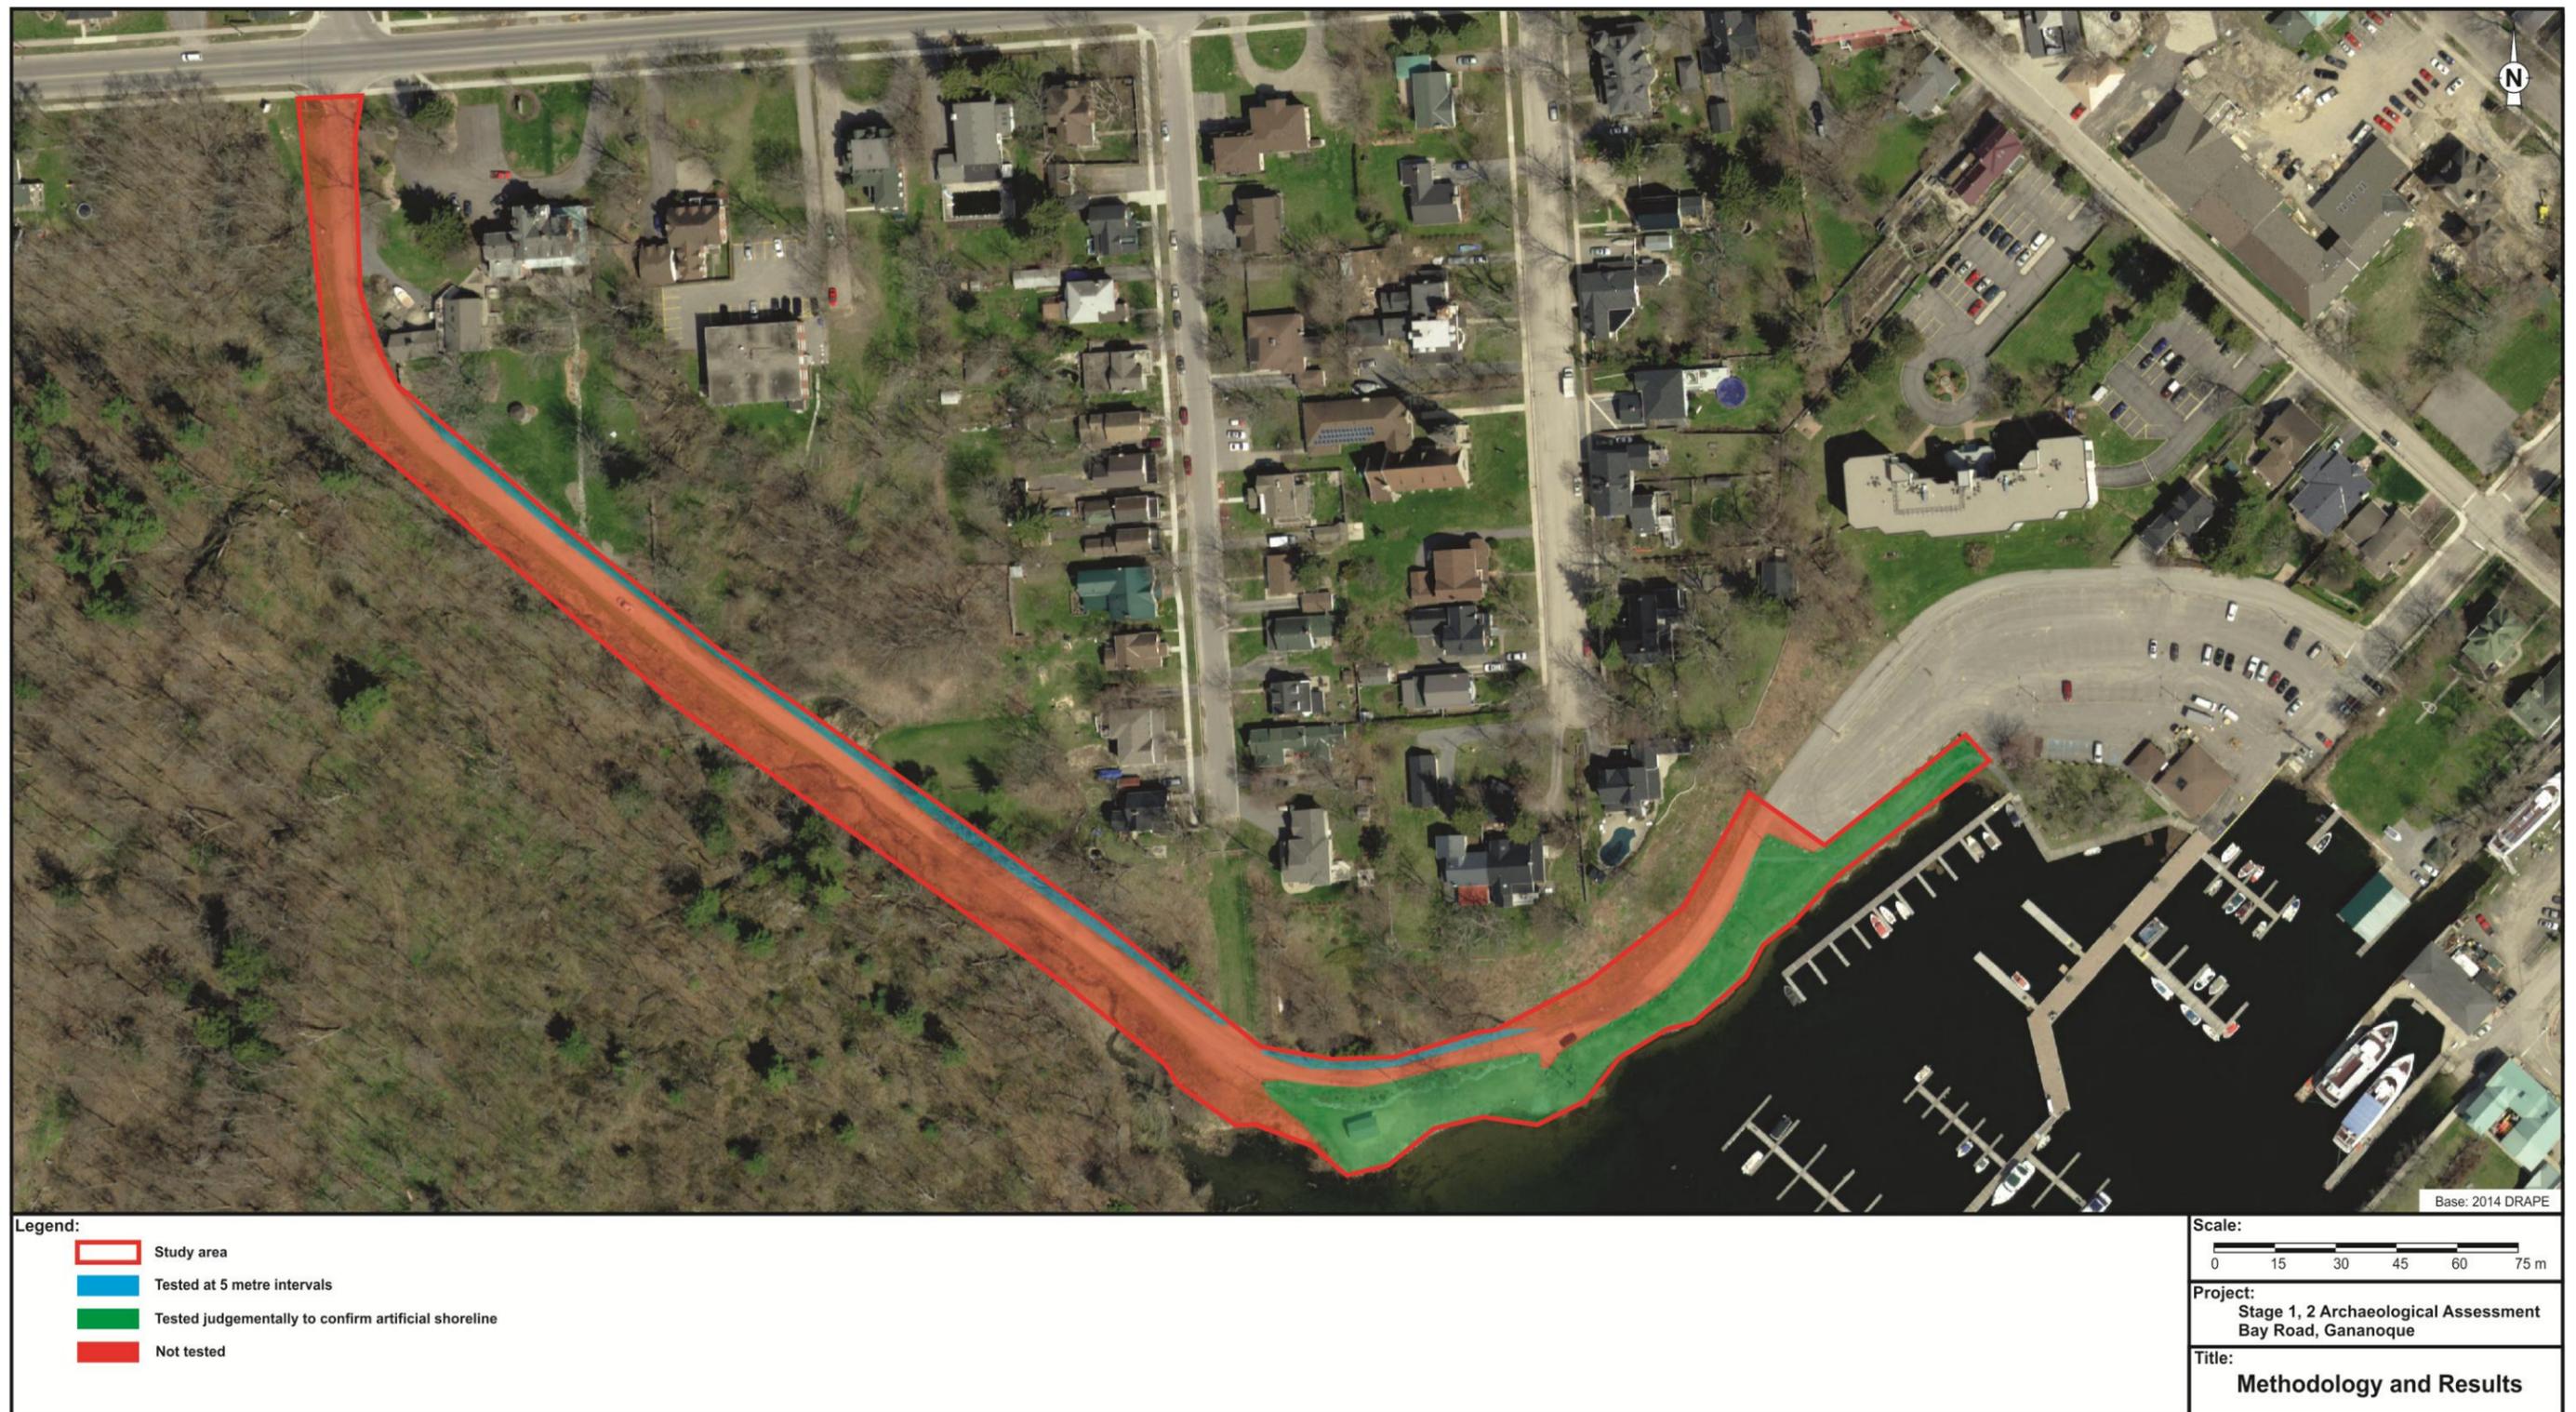
Map 12. Recent orthophotographic image of the study area with colour overlay indicating the methodology and results of the Stage 2 archaeological assessment.

No artifacts, features, or other cultural deposits of archaeological concern were noted during the Stage 2 assessment.

- 1) No further archaeological assessment for the subject area as presently defined in Map 2 is required. As a result, clearance of the archaeological condition placed on the study area should be granted.

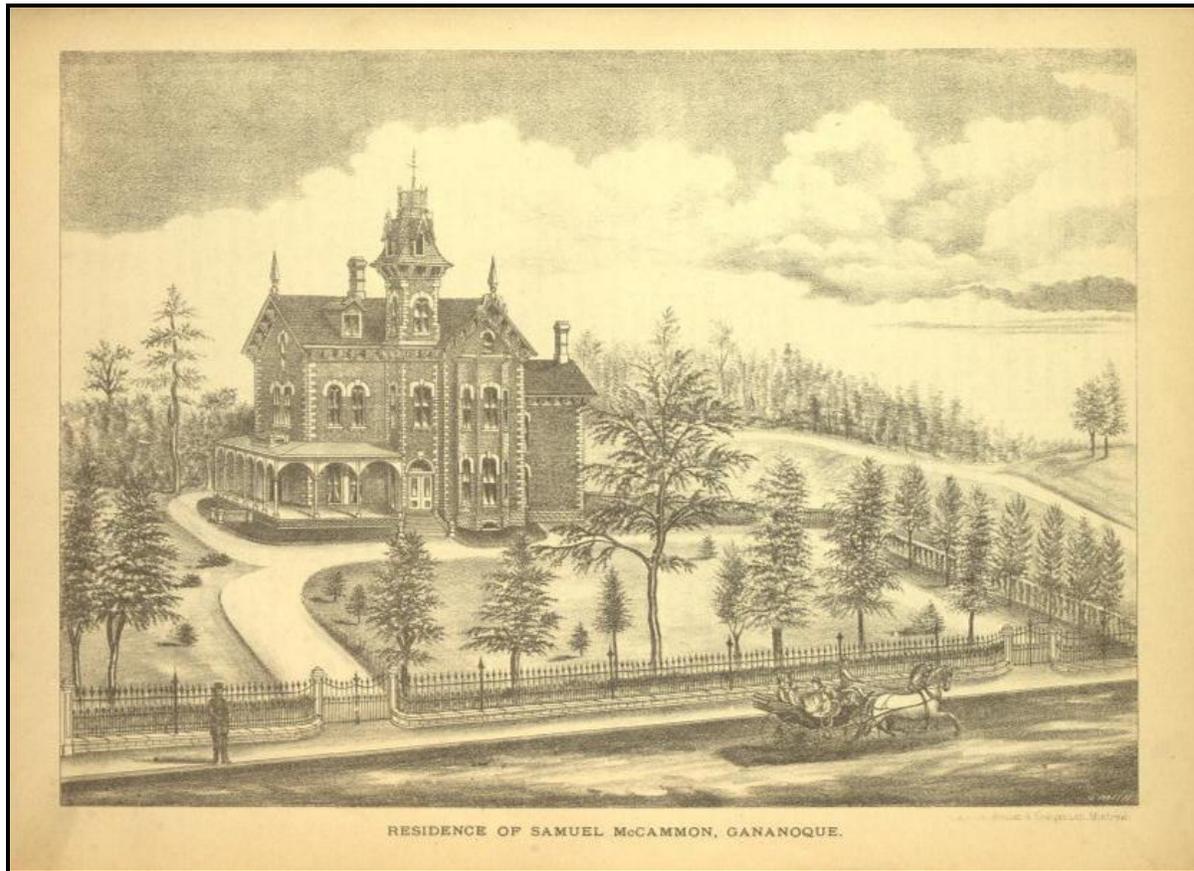
Image 1. Sketch of the mansion built for the Byers family in 1873. (Leavitt 1879:176) This mansion is located just east of the end of the study area. Presumably, Bay Road is depicted winding around behind the property.

In 1873 the grand red brick mansion at the corner of King Street and Bay Road was constructed for William Byers and his young family (Image 1). The high cost of building such a fine house were evidently enough that the young Byers family was forced to sell their home in 1879 to Samuel McCammon (LCLRO IV-783). In 1881 McCammon was listed as a manufacturer, and he lived with his wife, two grown children and one servant (LAC microfilm reel C-13232).

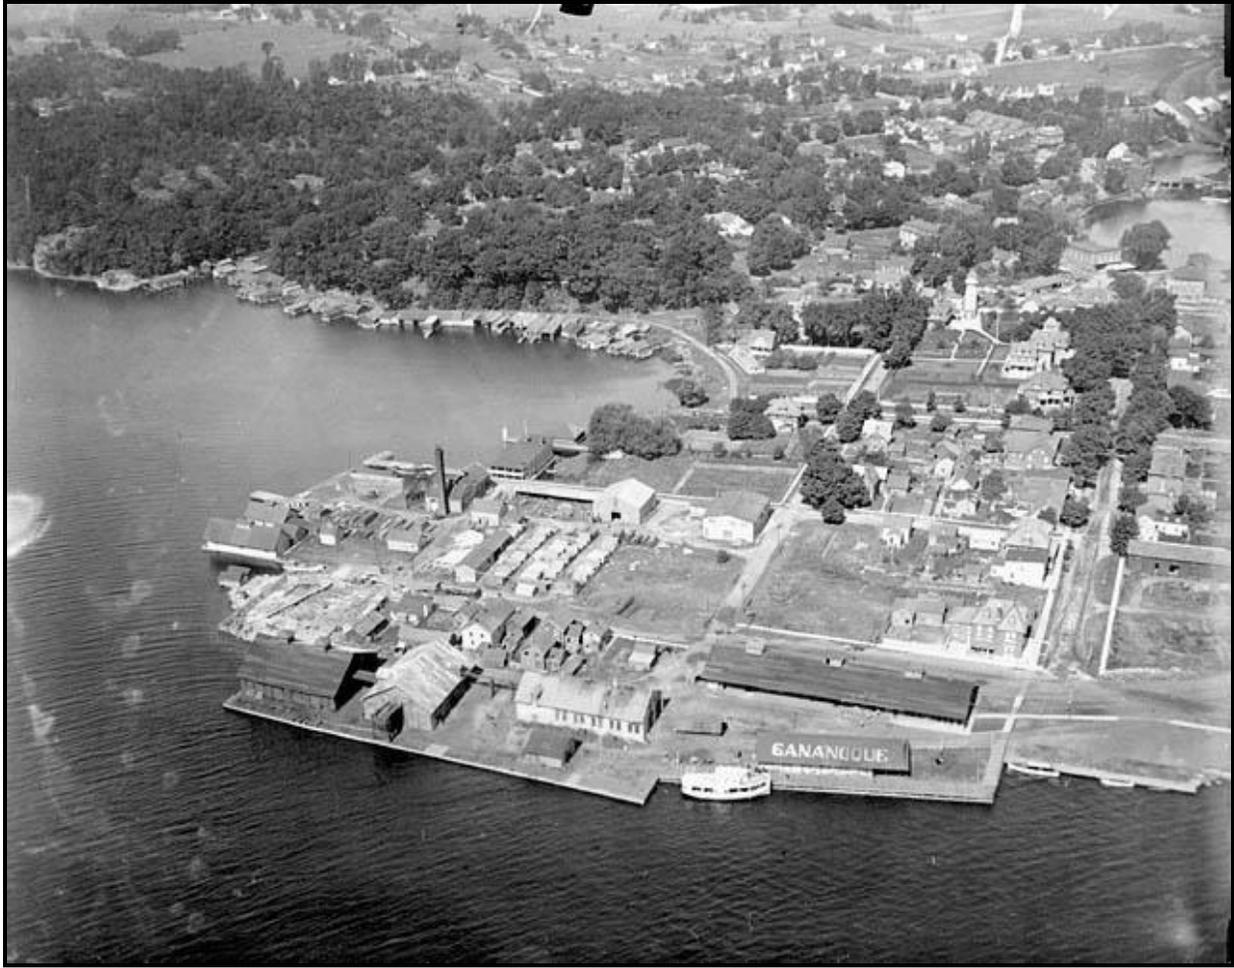
Image 2. Oblique aerial photograph of the waterfront in Gananoque, dating to 1920. (LAC a030654) The southern portion of the study area can be seen along the far shoreline. Note the boathouses which line the entire length of the shoreline.

A series of twentieth century aerial photographs reveal the gradual expansion of the shoreline into the St. Lawrence River at the southern limits of the study area. The first photograph dates to 1920 and illustrates the presence of several boathouses or similar structures which appear to extend from the southern edge of Bay Road out into the water (Image 2). The next available aerial photograph was taken in 1948, and provides an overhead view of the study area at that time (Map 7). In this photograph, portions of the study area are still under water, and the boathouses are concentrated to the east of what is now Rotary Beach. At this time, Princess Street extended all the way to Bay Road along the water's edge.

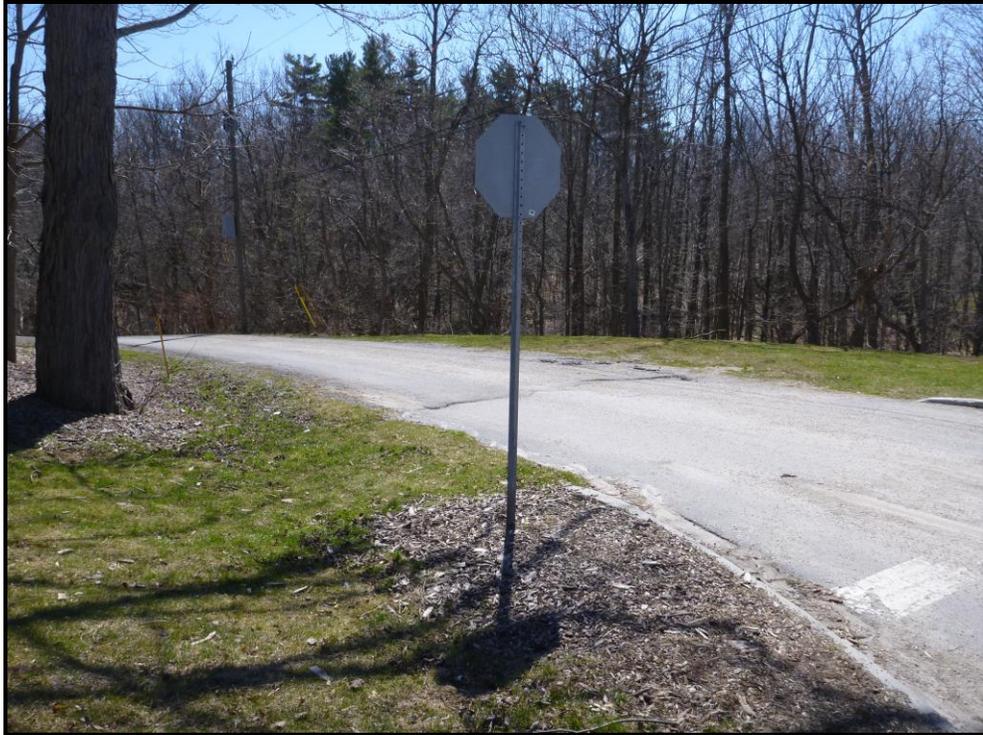
Image 3. View of the northern end of the study area, facing southwest towards Bay Road from the intersection at King Street West. (PR16-08D003)

The site visit confirmed the layout of Bay Road and Rotary Beach. Bay Road begins at the intersection of King Street in the northern end of the study area (Image 3), heads south for about 80 m (Image 4), then follows along the side of a steep hill in a south-easterly direction for approximately 280 m to Rotary Beach (Image 5). It then hugs the base of the hillside eastward for about 90 m (Image 6) before veering northeast towards the asphalt-paved marina parking lot (Image 7). The north end of the study area (at the King Street intersection) is approximately 90 m above sea level, but it slopes down considerably southward, reaching approximately 75 m above sea level at Rotary Beach.

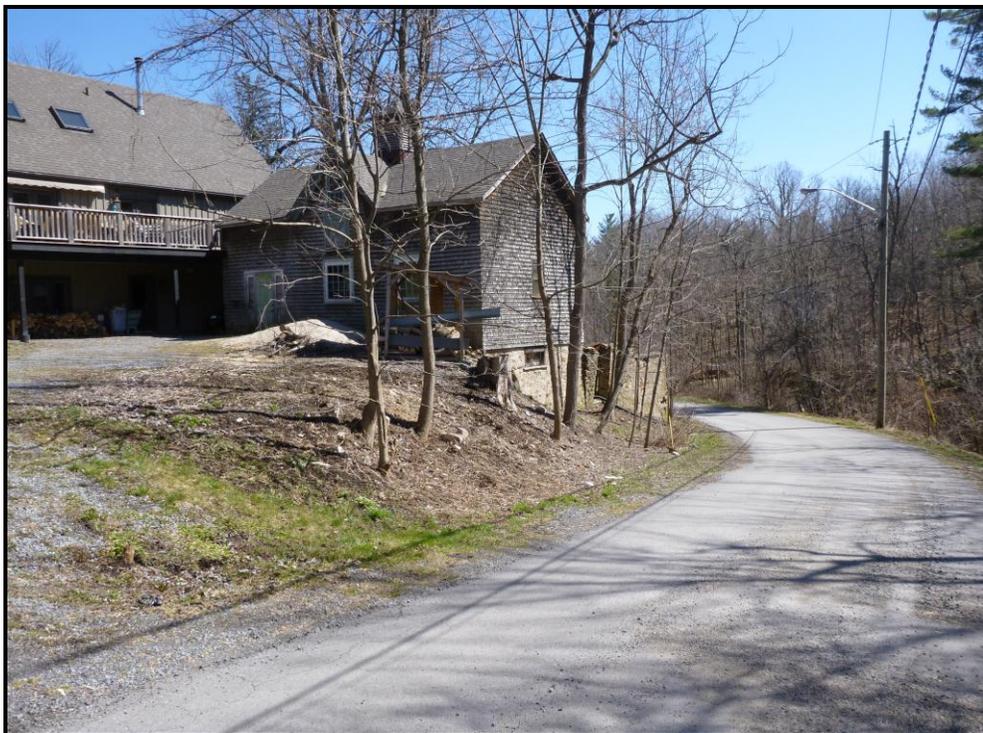
Image 4. View of a former carriage house or servants' residence associated with the Byers mansion, facing south-southeast, with Bay Road on the right. (PR16-08D013)

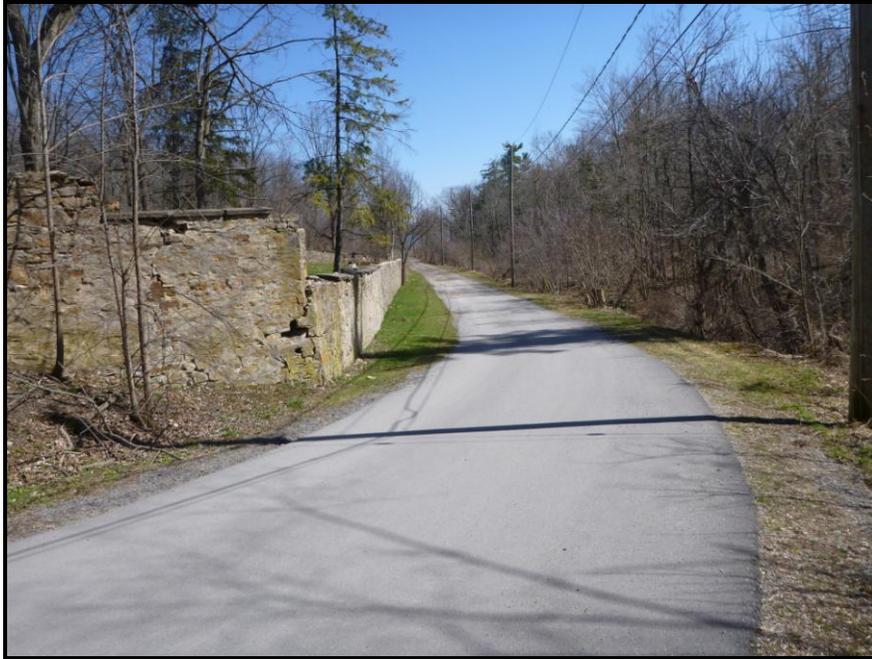
Image 5. View of the stone retaining wall running parallel to Bay Road, facing southeast.
(PR16-08D018)

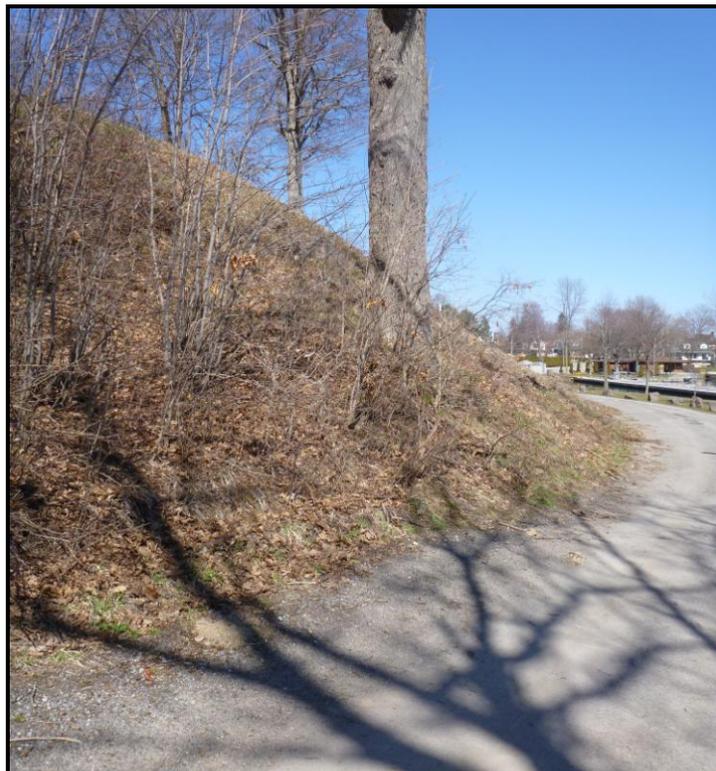
Image 6. View of the slope along the north edge of Bay Road near the beach, facing east.
(PR16-08D108)

Along the northern edge of Bay Road, the ROW extends a distance of between 1 m and 2 m. Near the intersection at King Street, this part of the ROW contains a natural gas line for about 60 m in a southerly direction. A stone retaining wall associated with the Byers mansion acts as the study area boundary for approximately 70 m (see Image 5). Beyond this to the south is a permanently water-saturated zone associated with a culvert (Image 13). To the north of Rotary Beach the northern edge of the ROW is relatively flat and level before sloping dramatically upwards just beyond the study area limits (see Image 6).

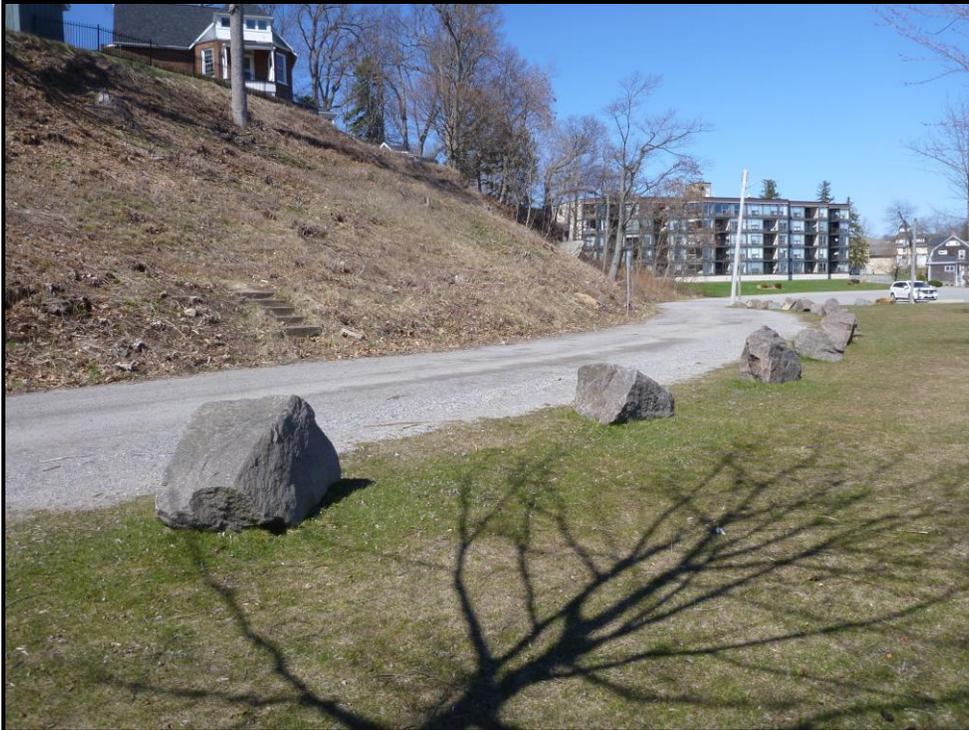
Image 7. View of the slope along the north edge of Bay Road near the marina parking lot, facing northeast, with the artificial waterfront terrace in the foreground. (PR16-08D116)

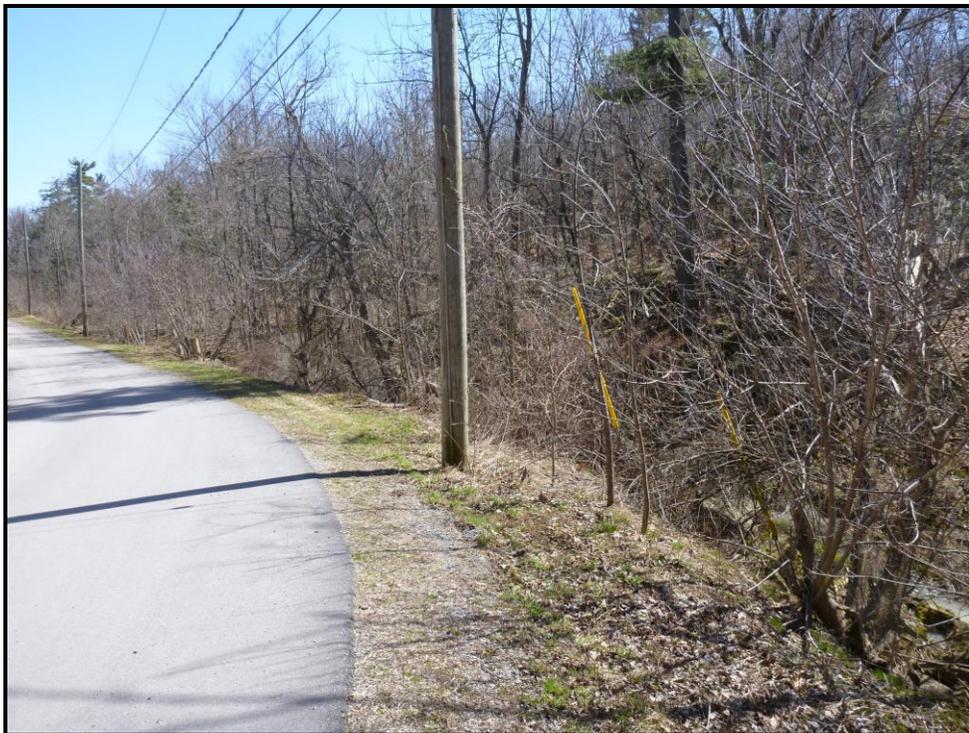
Image 8. View of the western shoulder of Bay Road, facing south-southeast near the former carriage house, with the unnamed creek visible to the right. (PR16-08D019)

The ROW along the western edge of the roadway beginning at King Street and continuing southward to Rotary Beach consists of a gravel embankment approximately 0.5 m and 1 m in width (Image 8), before sloping drastically down to the unnamed creek which flanks the roadway and empties into the St. Lawrence River (Image 9). At Rotary Beach, clean sand fill has been added near the creek mouth to create the swimming beach, where two separate stone retaining walls are also present (Image 10). The first retaining wall consists of cut limestone blocks and flanks the southern edge of Bay Road at the beach, while the second retaining wall consists of large rough cut boulders piled directly along the shoreline to retain the beach sand (Image 11). Further to the east, smaller cobbles have been used in the same way to retain the artificially extended shoreline (Image 12).

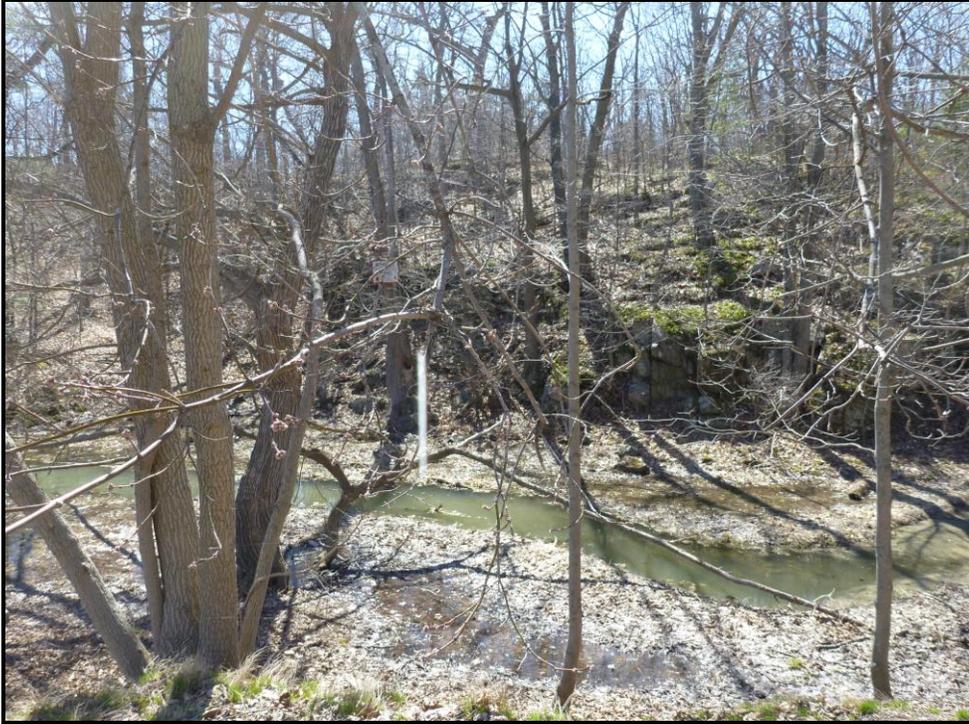
Image 9. View of the unnamed creek from Bay Road, facing west-southwest. (PR16-08D081)

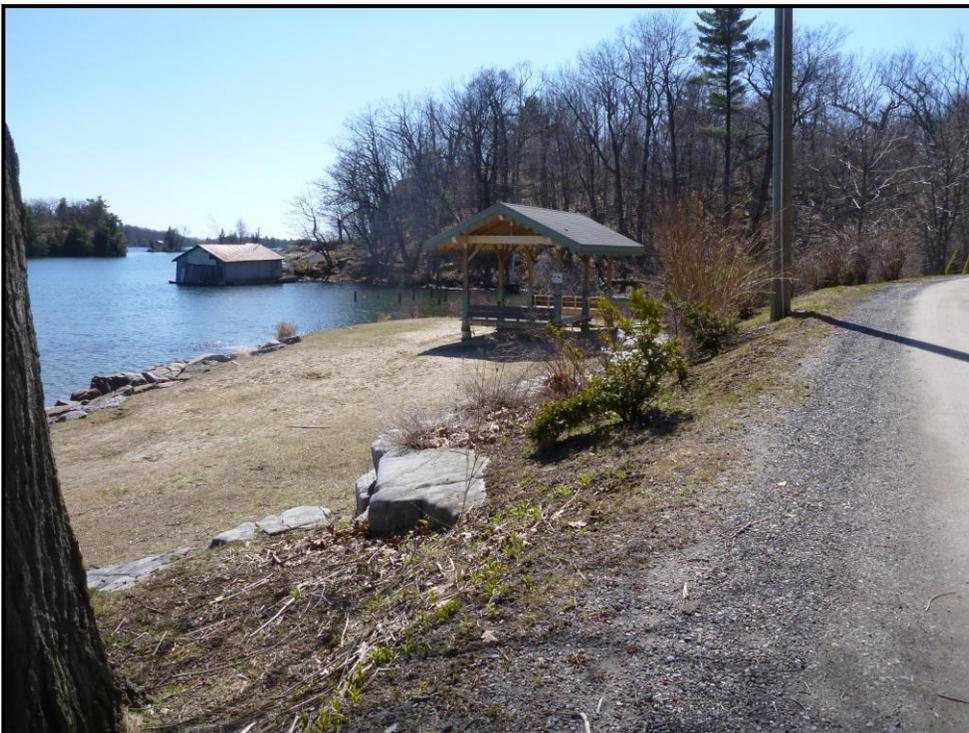
Image 10. View of the imported sand beach and pagoda from Bay Road, facing west-southwest. (PR16-08D105)

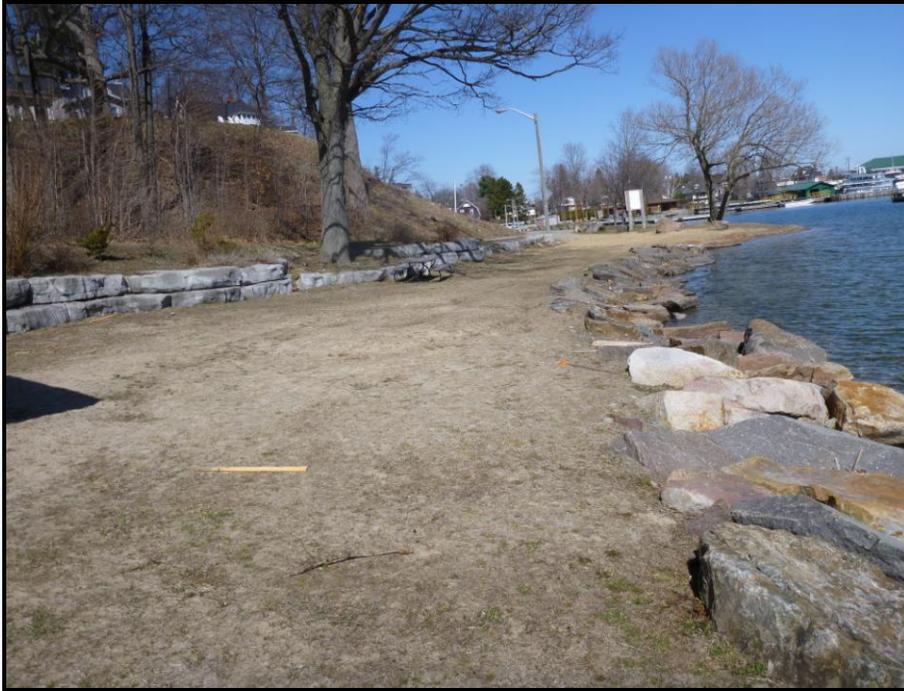
Image 11. View of the imported sand beach, facing east-northeast from the pagoda, with the shaped limestone block retaining wall visible on the left, and the large boulder retaining wall for the beach on the right. (PR16-08D103)

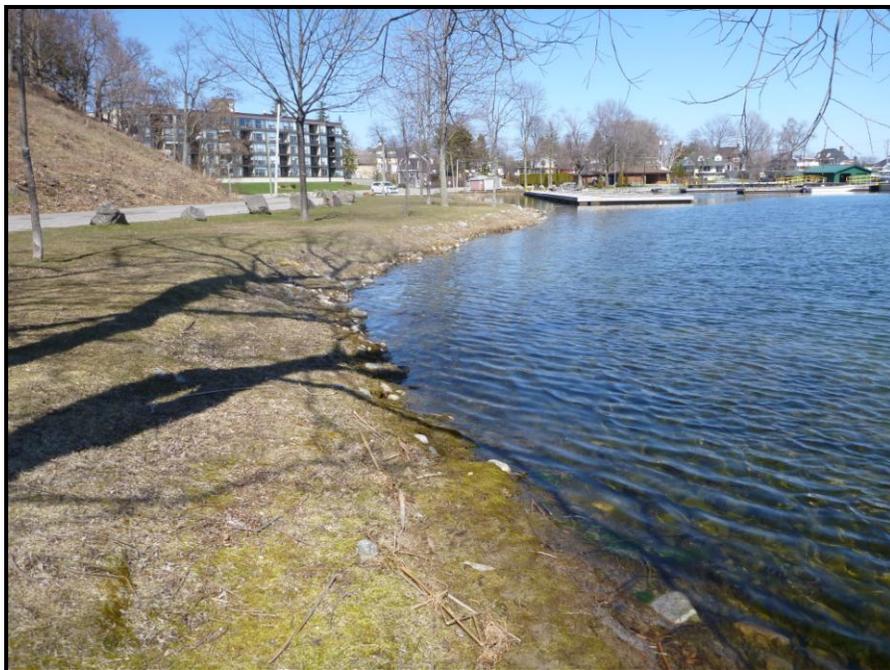
Image 12. View of the shoreline to the east of the sand beach, facing east-northeast, with Bay Road on the left. (PR16-08D111) Note: although obscured by vegetation, cobbles have been piled along the edge of the shoreline here to act as a retaining wall for the reclaimed shoreline.

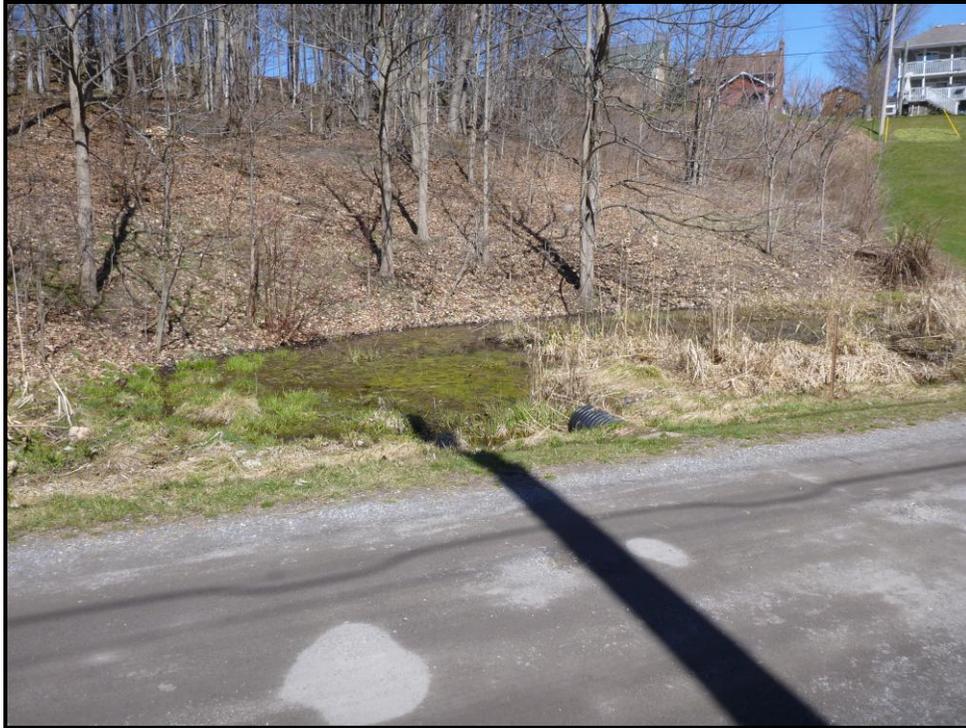
Image 13. View of a permanently water-saturated area associated with a culvert passing below Bay Road, facing east-southeast. (PR16-08D046)

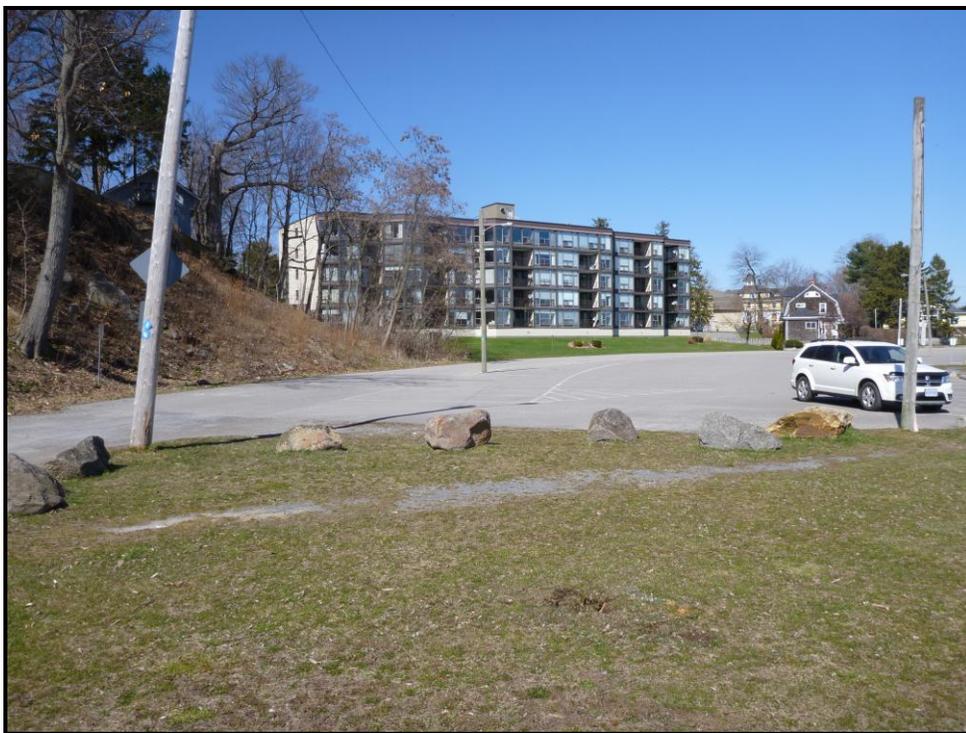
Image 14. View of the parking lot for the beach and wharf at the southeast end of the study area, facing northeast. (PR16-08D120)

For the most part, the roadway is composed of packed gravel and stone dust. Near the intersection at King Street it is paved asphalt for a distance of about 10 m. At the southeastern end of the study area the roadway becomes the marina parking lot, which is also paved asphalt (Image 14).
