STAGE 1 AND 2
ARCHAEOLOGICAL ASSESSMENT
BAY ROAD AND ROTARY BEACH UPGRADES
GEOGRAPHIC TOWNSHIP OF LEEDS
TOWN OF GANANOQUE, ONTARIO

PRAS Project No.: PR16-08

Date: July 26th, 2016
Original Report

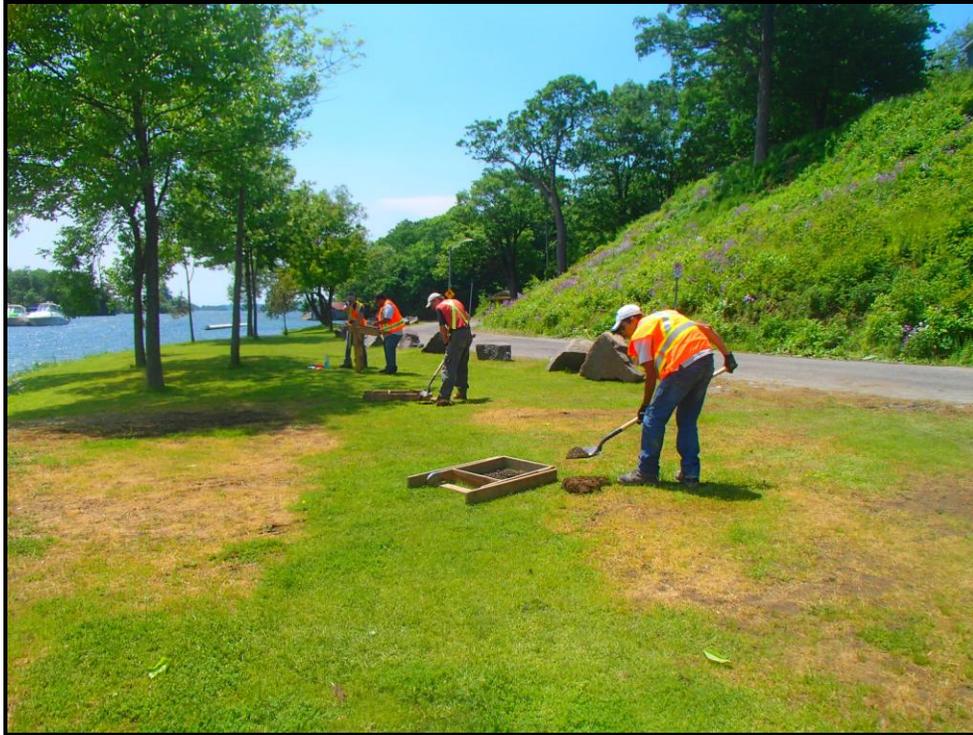
Image 15. View of crew test-pitting near the water's edge to identify the limits of the original shoreline, facing west. (PR16-08D127)

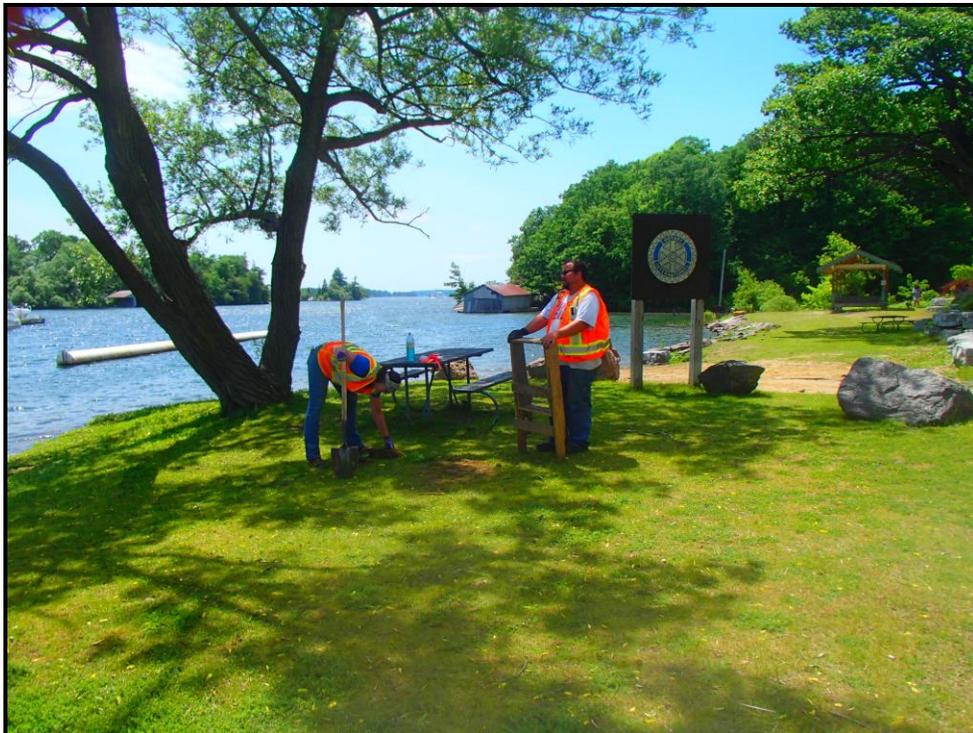
Image 16. View of crew test-pitting near water's edge to identify the limits of the original shoreline, facing west-southwest. (PR16-08D129)

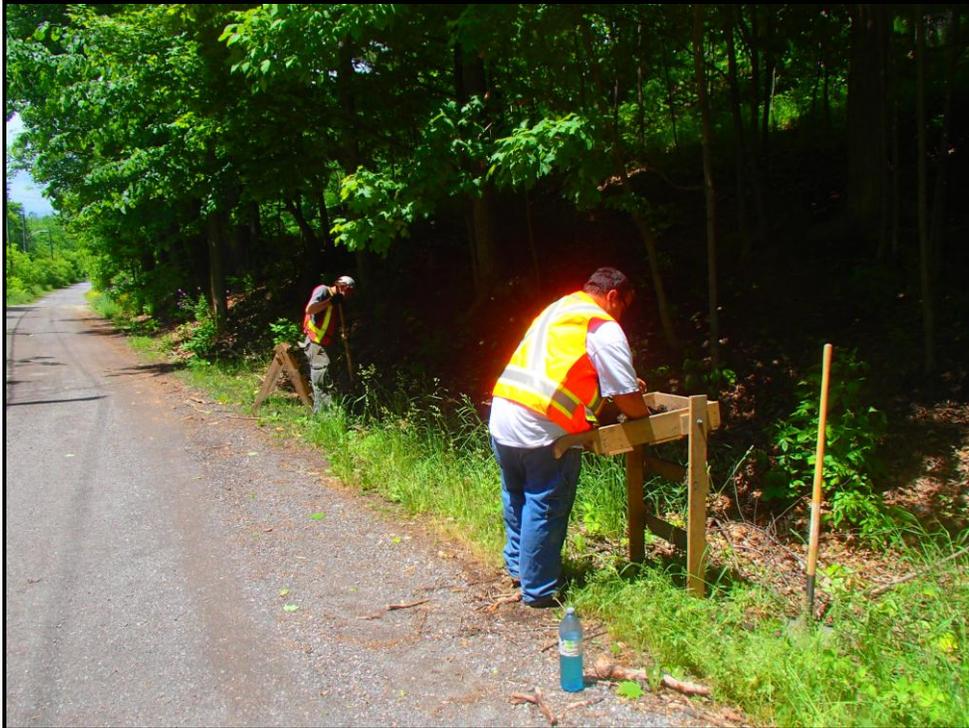
Image 17. View of crew test-pitting along the northern/eastern edge of Bay Road, facing northwest. (PR16-08D131)

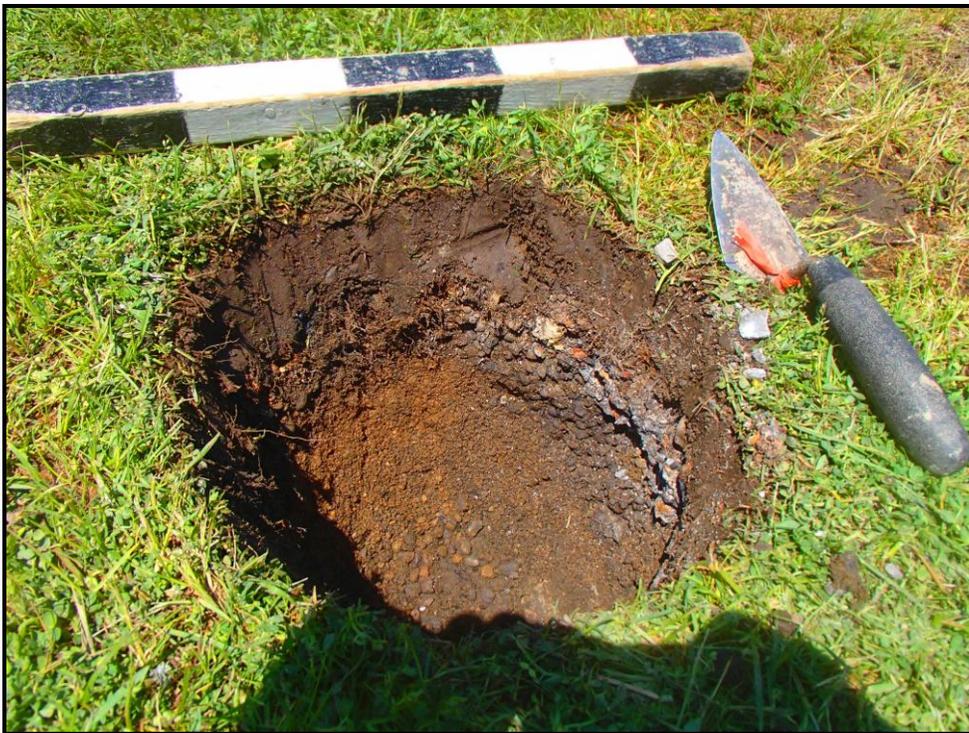
No evidence of natural stratigraphy was found to the south of Bay Road, but instead the presence of gravel, sand, and industrial waste fills were confirmed - typical deposits within reclaimed waterfront areas (Image 18). The level area to the north of the road at Rotary Beach was found to contain natural stratigraphy, consisting of a dark brown sandy loam topsoil (c. 15 cm in depth) directly atop the B horizon which consisted of compact, tan clay (Image 19). Test pits elsewhere along the roadway were similar, although some contained a layer of gravel between the topsoil and subsoil, which varied in thickness depending on proximity to the actual road. Several test pits immediately south of the stone retaining wall associated with the Byers mansion were found to fill up with groundwater as they were being excavated, indicating the main drainage route for the property (Image 20). In fact, deliberate gaps in the masonry were noted at regularly spaced intervals along the base of this wall for the purpose of draining the backyard (Image 21). No artifacts or features of cultural heritage value or interest were found during the course of the Stage 2 fieldwork.

Image 18. Typical test pit within the extended shoreline fill to the south of Bay Road, along the water's edge, facing north-northeast. (PR16-08D128)

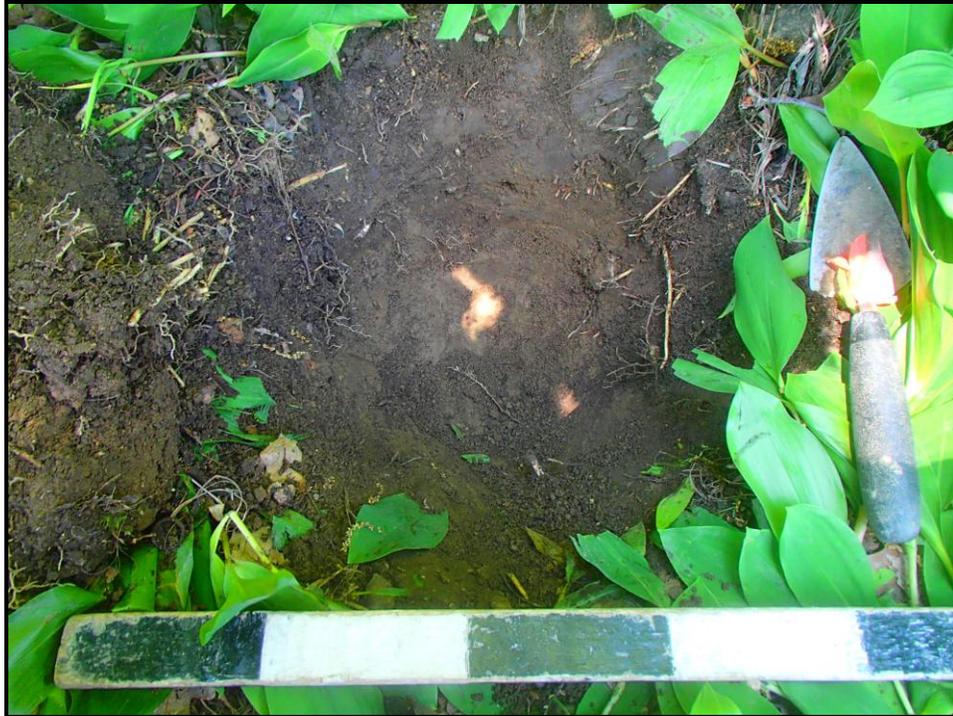
Image 19. View of a test pit demonstrating the natural soil stratigraphy immediately north of Bay Road at Rotary Beach, facing north. (PR16-08D130)

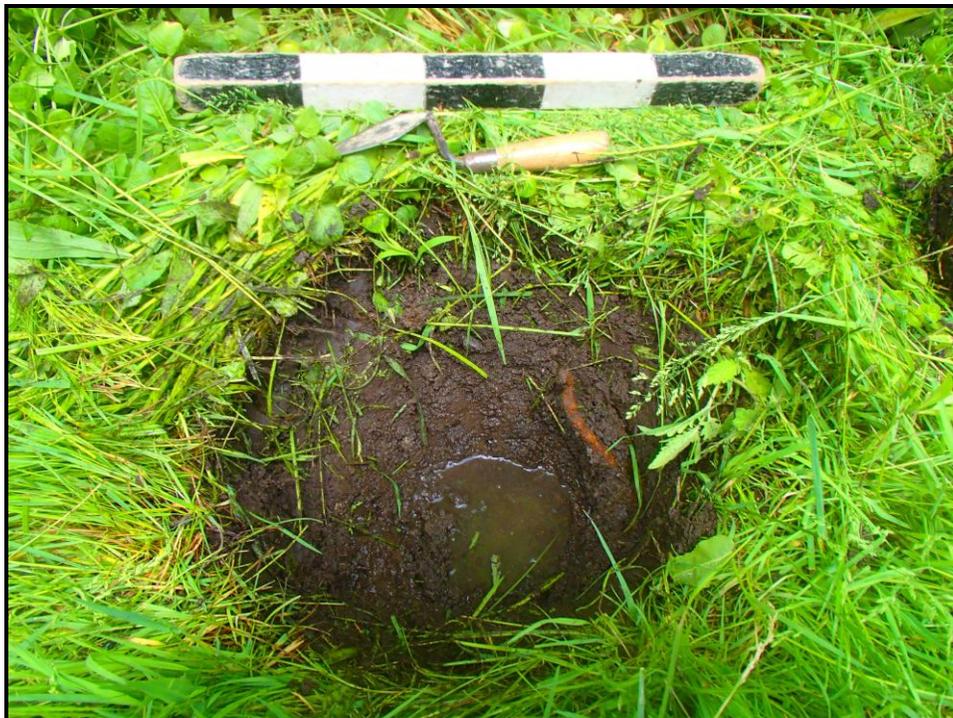
Image 20. View of a waterlogged test pit near the base of the stone retaining wall which runs along much of the eastern edge of the ROW, facing east. (PR16-08D132)

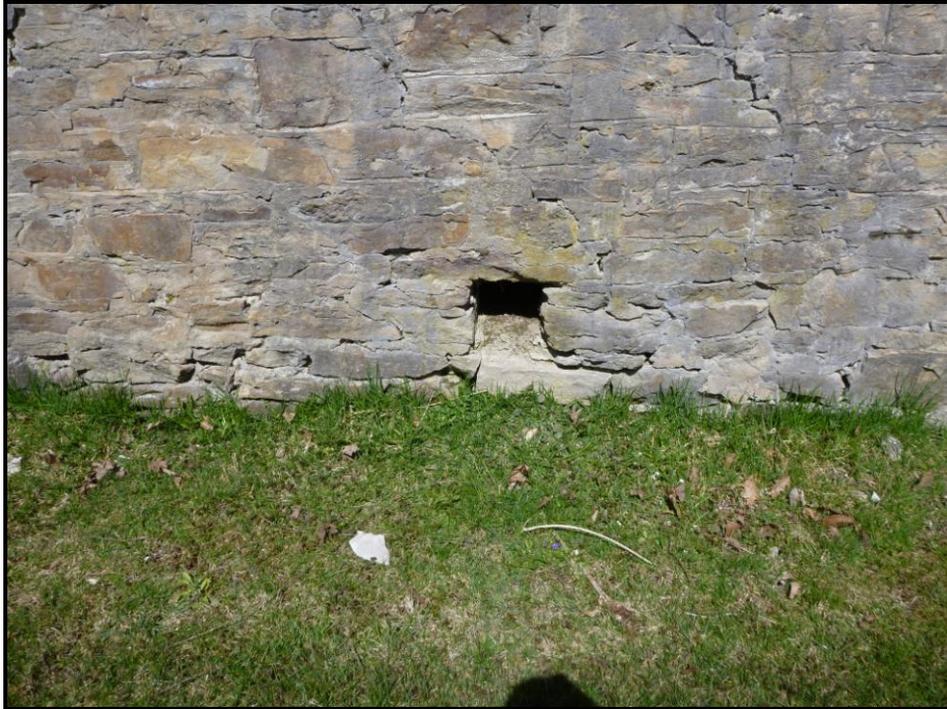
Image 21. View of a drainage hole in the masonry wall which borders a portion of the study area, facing northeast. (PR16-08D026)
