2016 Bridge Inspections

Town of Gananoque

- June 2016 -

Keystone Bridge Management Corp.

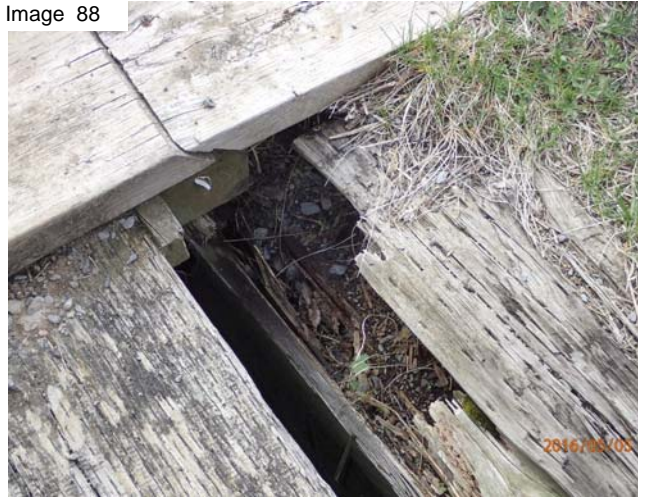
Image 88

Rotted timber south end

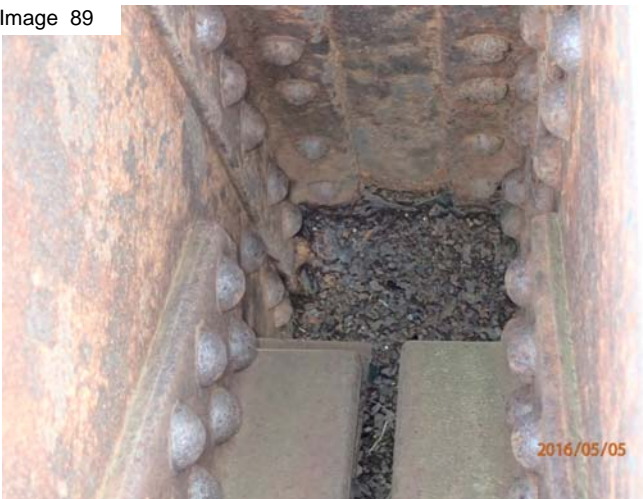
Image 89

Typical panel point debris

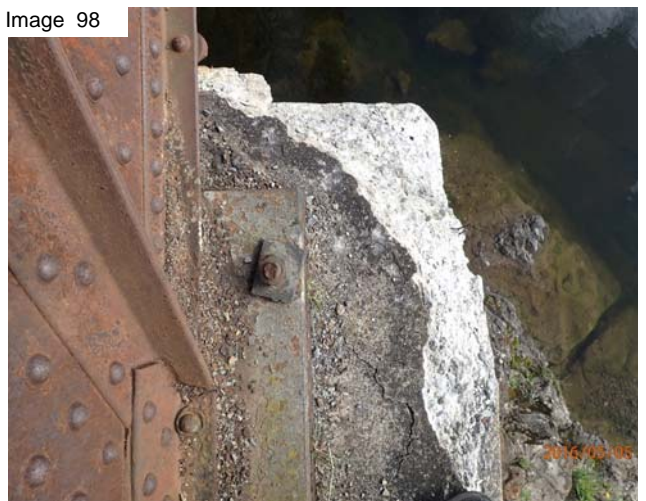
Image 98

Delamination at southeast bearing

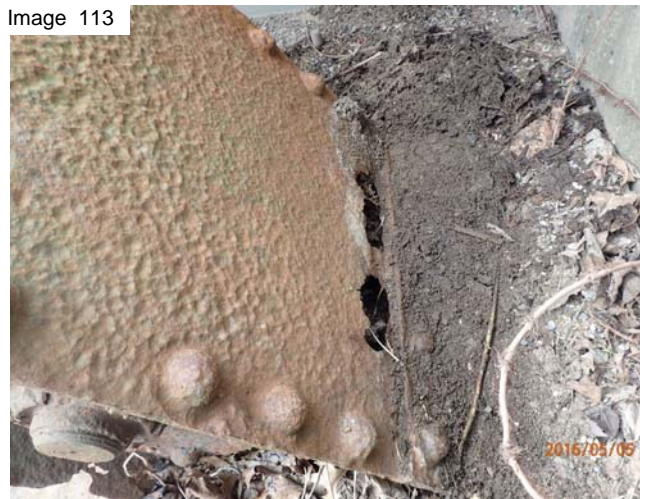
Image 113

The Hudson Bridge is exhibiting severe corrosion and rust perforation of its primary structural components such as the floor beams and truss compression members. As it continues to corrode it is becoming increasingly structurally unreliable. It should not be relied on to carry traffic of any description after 2030. Until then it can be managed by load posting. However, the Town is assuming some risk by continuing to maintain the bridge open to traffic. Ideally the bridge should be taken out of service and replaced with a modern bridge. The recommended year of 2020 is flexible and represents a reasonable time for the Town to respond and obtain funding for a replacement bridge.

Perforated truss northwest end diagonal

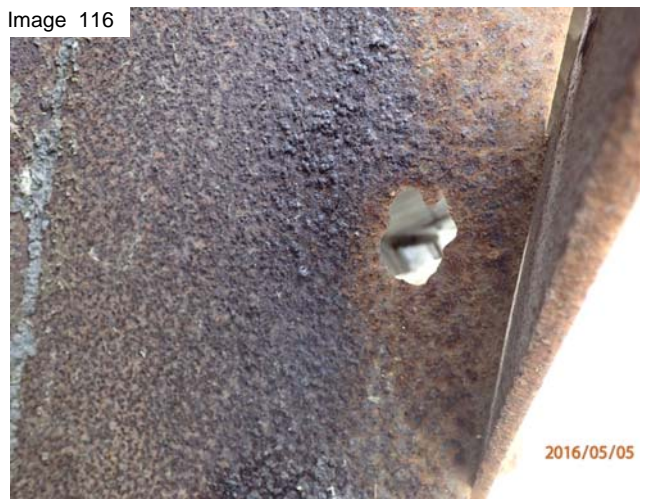
Image 116

Perforated web in northeast diagonal

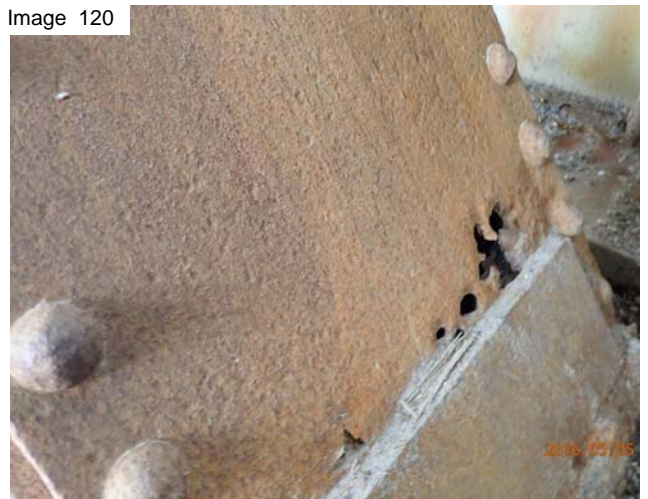
Image 120

Perforated web in southeast diagonal

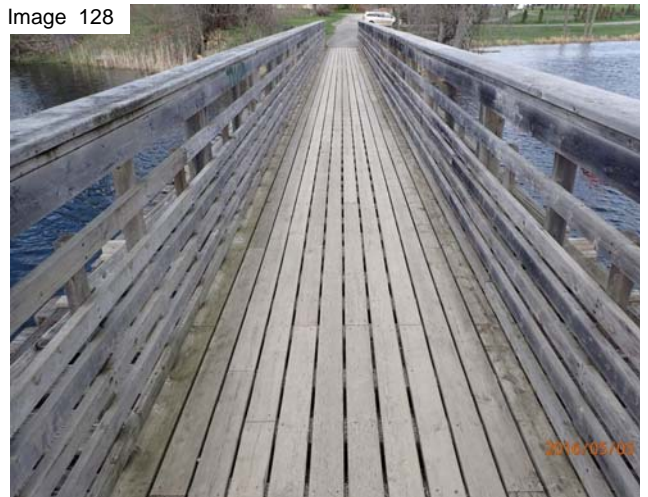
Image 128

Some damage down middle from unknown source. Old railroad ties are decaying and supporting vegetation growth.

Typical deck

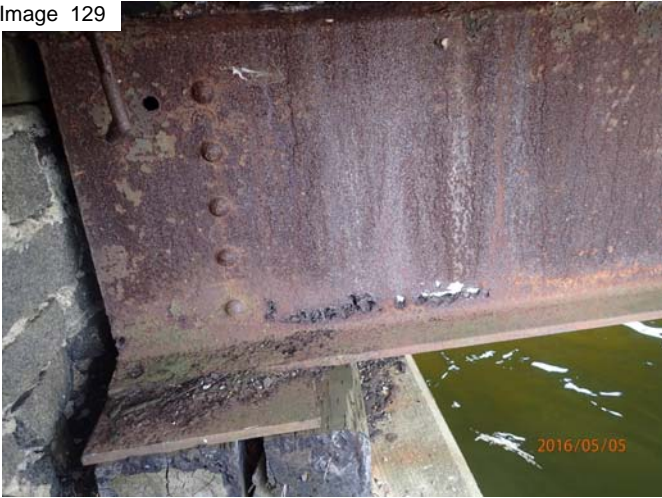
Image 129

Bridge girders are severely corroded at ends and may settle or fail with little warning. Ties are increasingly decayed. Highly recommend a more thorough review with a boat inspection in order to assure continued public safety. Should consider closing this bridge for public use by 2020.

Northeast girder end

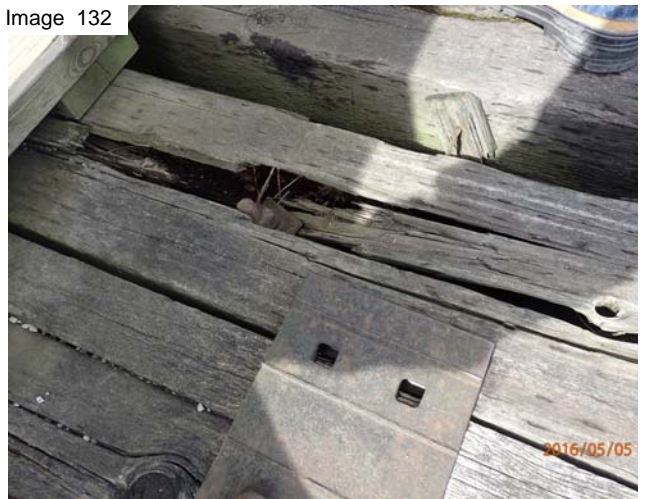
Image 132

Timber 8" x 8" railroad ties display severe decay.

Typical rotted tie

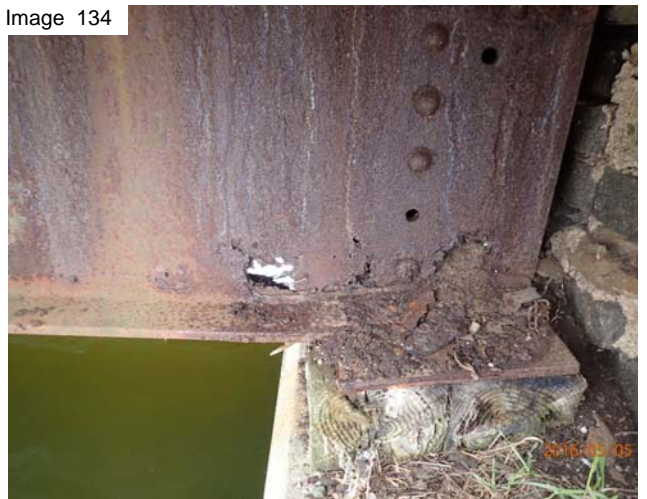
Image 134

West girder end

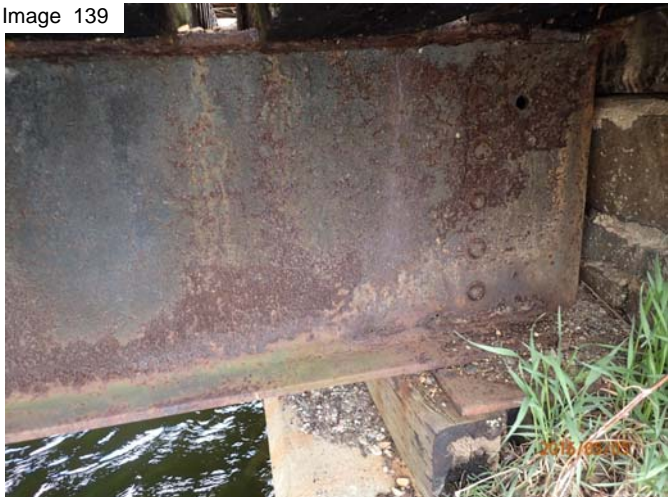
East girder ends at abutment wall

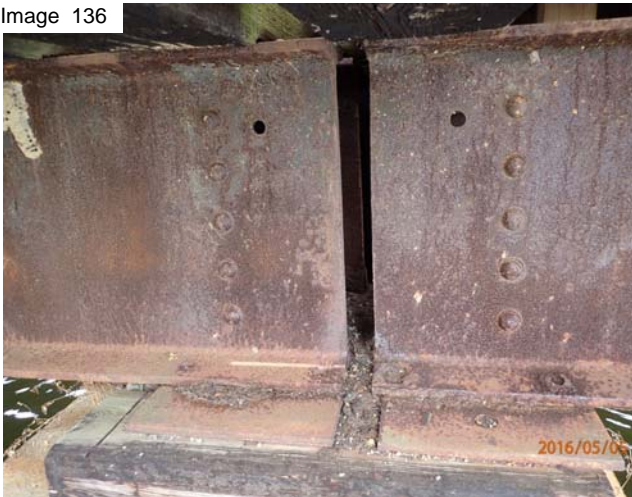
South face of west pier girders

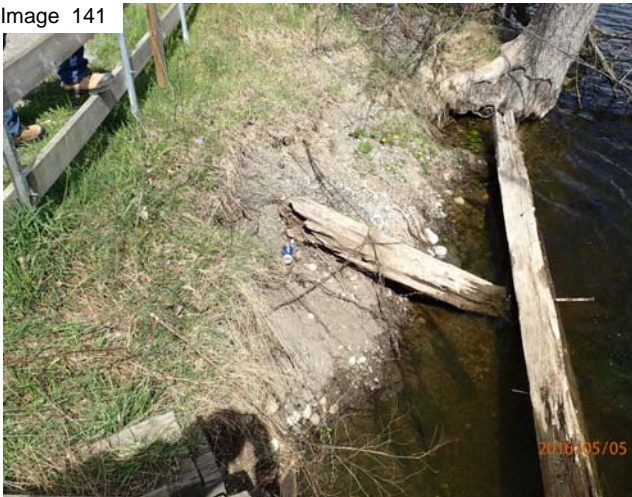
Embankment	Damage 0.0%	
	Maintenance Slope revetment	
	Capital Rec. None	
	<i>Stable, groomed, with some local erosion. An old timber retaining wall in NW quadrant has failed.</i>

Northwest embankments

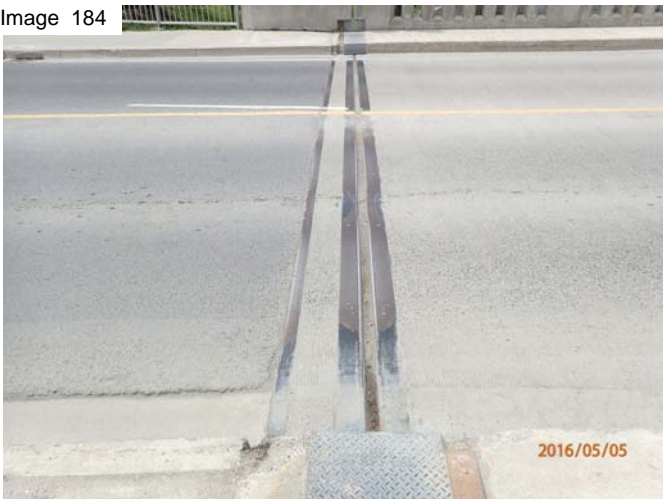
Image 184

South expansion joint

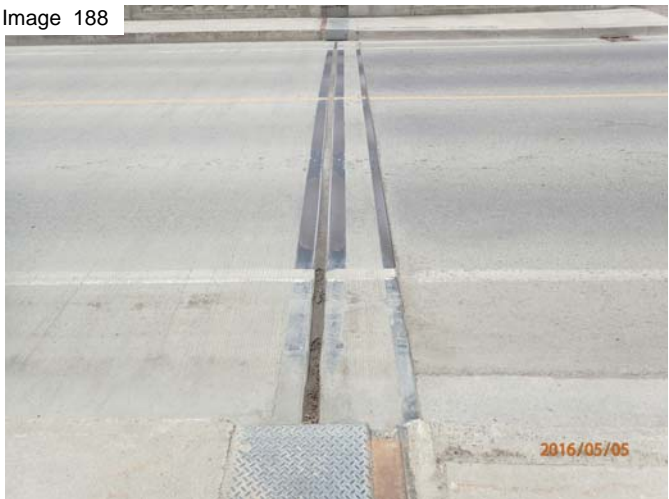
North expansion joint

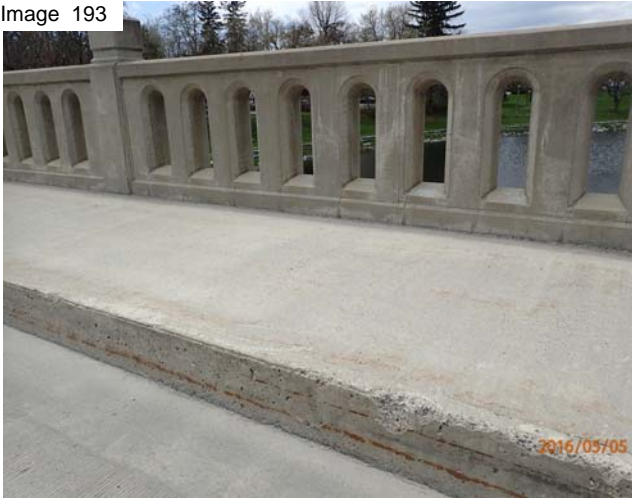
Typical sidewalk and railing

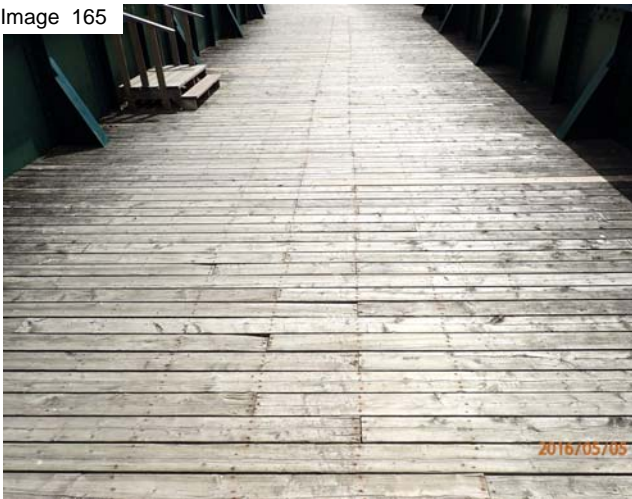
Bridge deck has a number of decayed planks. Repair locally as a maintenance item. Structure experienced punch through failure at north end of north span. Hole from punch through covered by plywood sheets. Recommend limiting structure to pedestrians only. Wood stringers are expected to be starting to decay.

Typical deck

Replace timber deck \$170,000

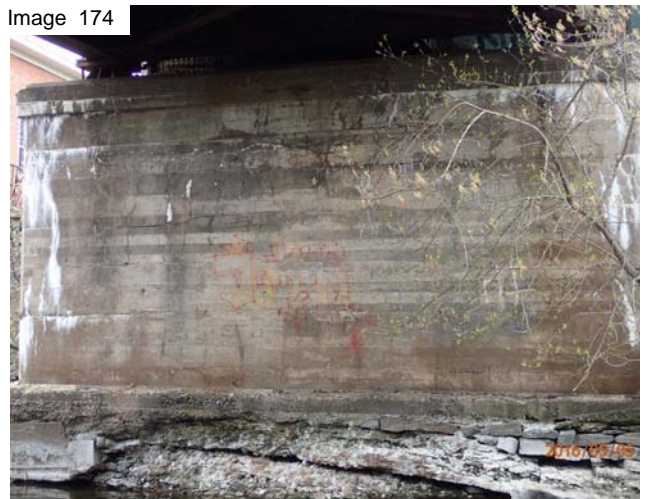
North face of pier

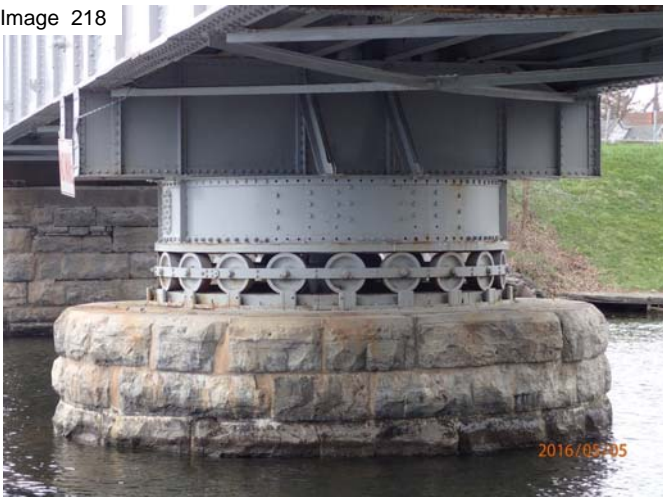
Image 219

Rocker or Roller Bearing (1)	Defects 0.0%	
Pier Bearings	Damage 0.0%	
Length:	Maintenance None	Partial Inspection
Width:	Capital Rec. None	
Height:	<i>The rollers for the turn table appear to be functional.</i>	
Water Channel (1)	Defects 0.0%	
Channel	Damage 0.0%	
	Maintenance None	
	Capital Rec. None	
	<i>Deep navigable channel.</i>

Pier with rotation system

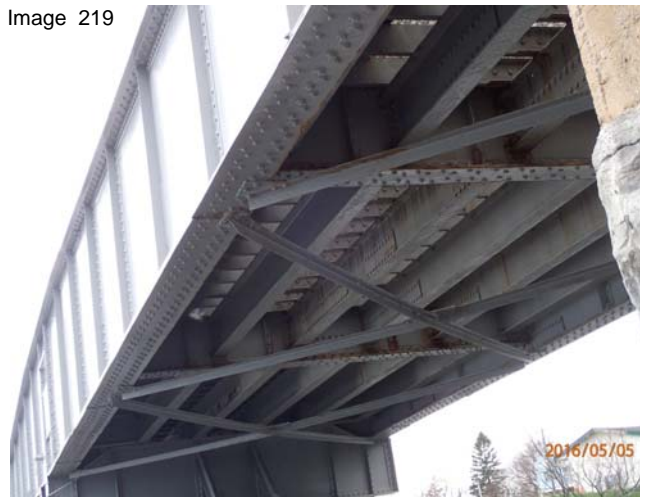
Image 220

East span soffit

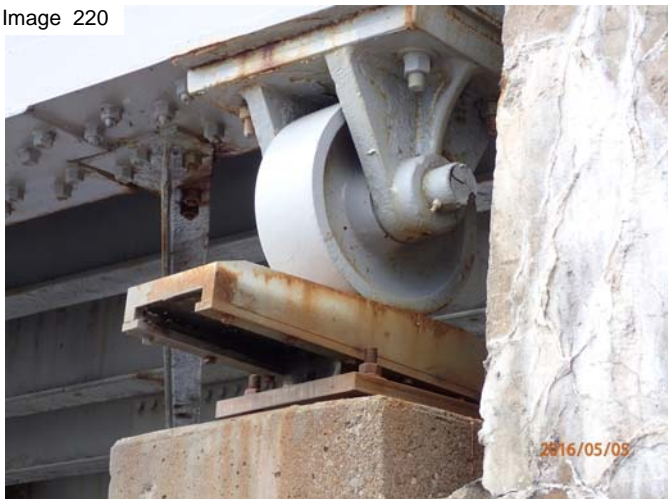
Image 222

Typical roller for rotating system

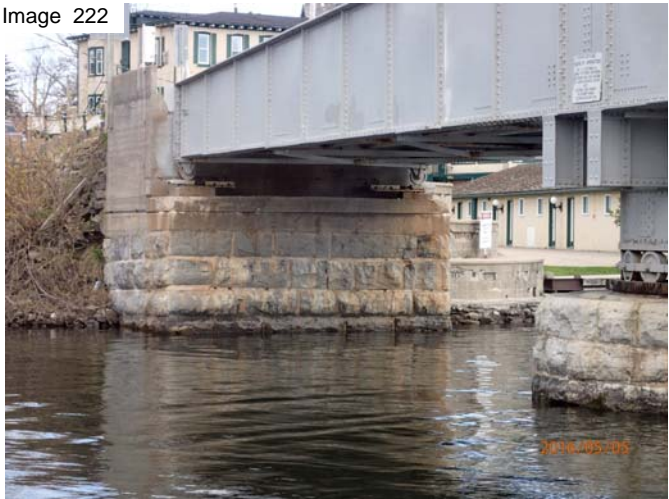
Image 221

East abutment wall

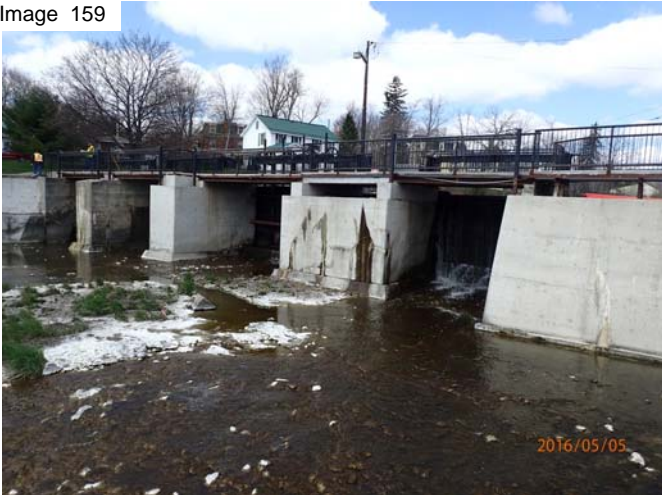
Image 159

East elevation

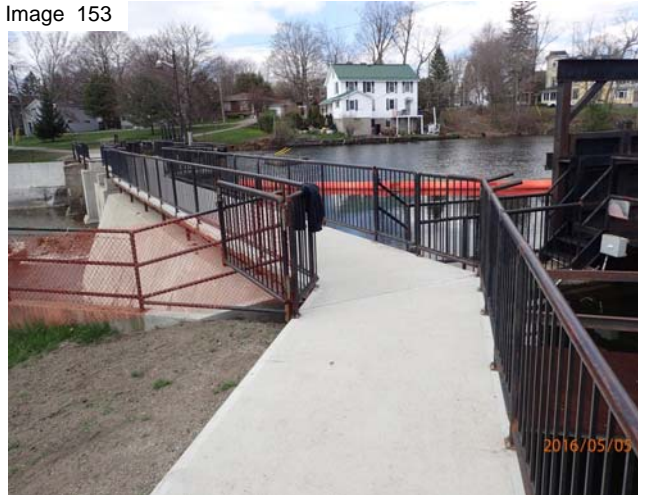
Image 153

North approach

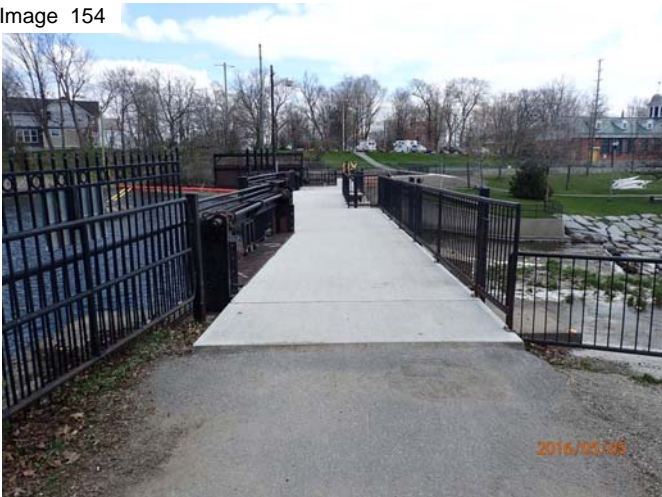
Image 154

South approach

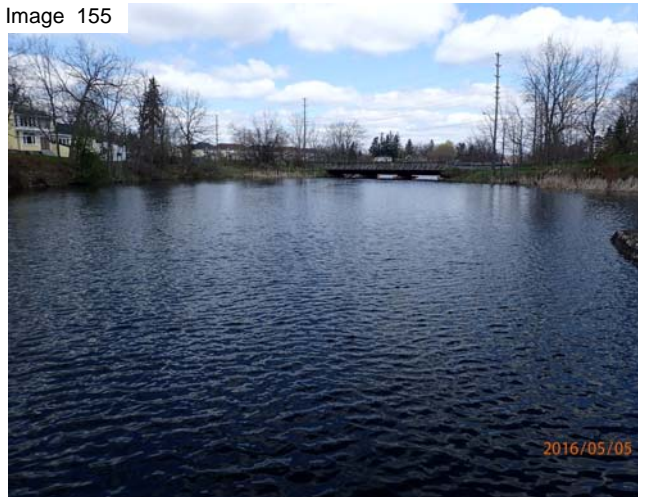
Image 155

Upstream channel west

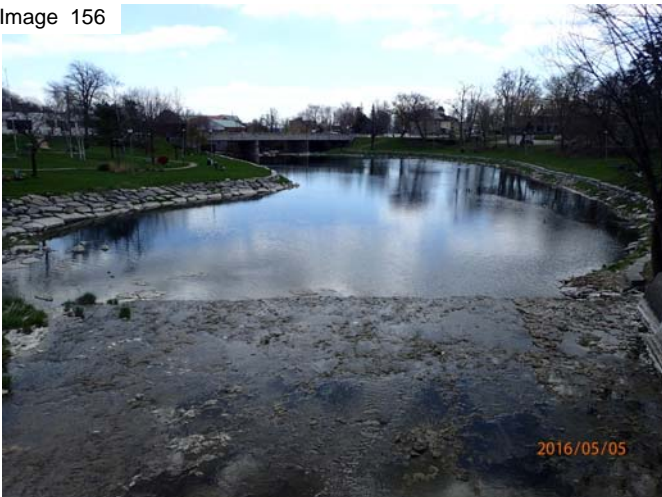
Image 156

Downstream channel east

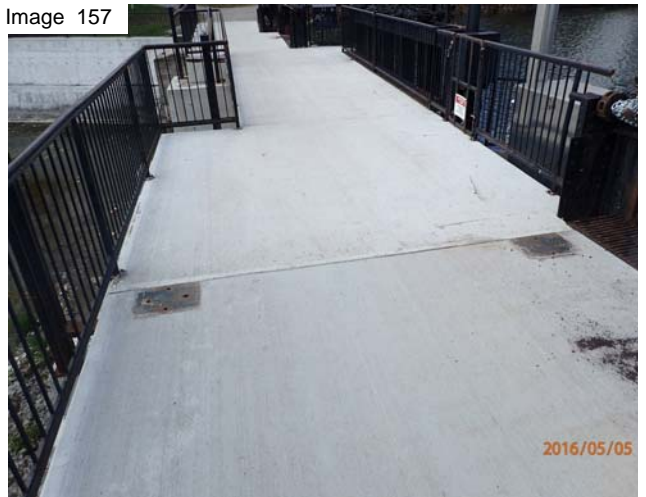
Image 157

Typical deck

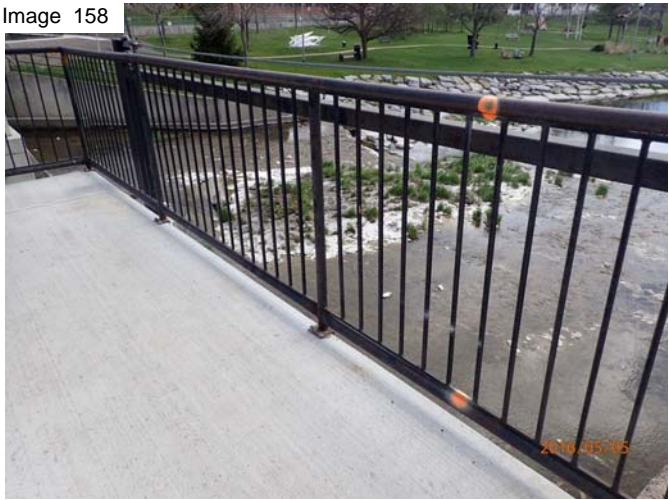
Ped Steel Post & Panel (2)	Defects	10.0%	Minor Tarnishing, Minor Corrosion
Railings	Damage	0.0%	
Length:	41.8 m	Maintenance	None
Width:		Capital Rec.	None
Height:	1.1 m		<i>Original pedestrian railing recycled.</i>

Typical railing

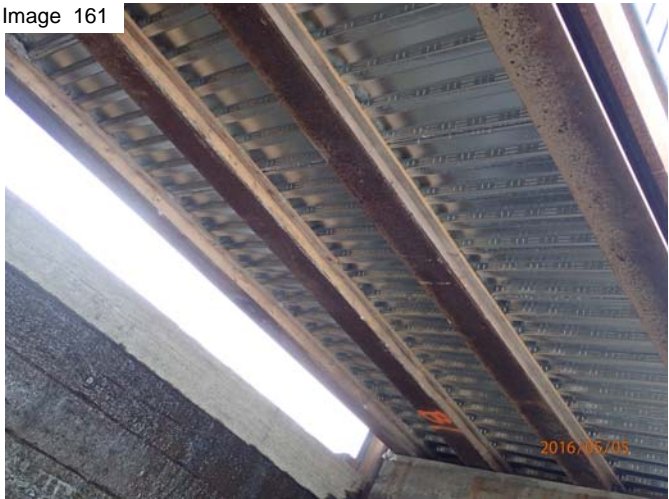
South span soffit

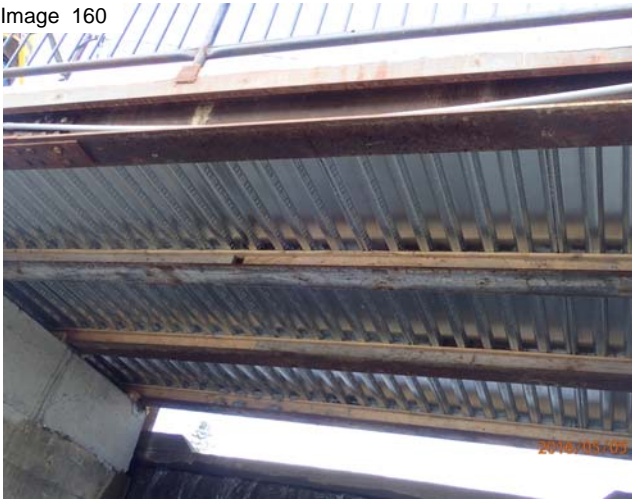
North span soffit

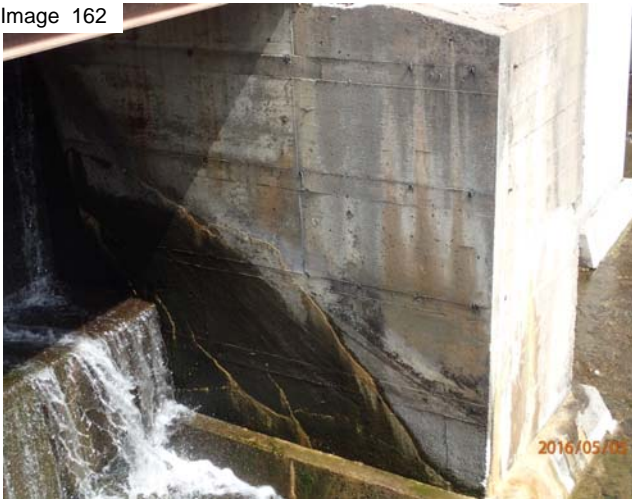
Old south pier
